Cranor Inspection Services, LLC.

Client Information: Record Number Sample 1

Type & Scope of Inspection: *Home Buyer Inspection*

Home Type & Age: *Single Family, One story (Ranch)*

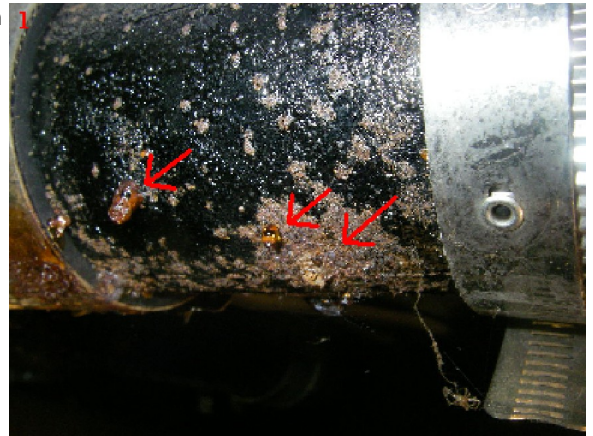
The horizontal cast iron drain pipes in the crawl space have deterioration (rust scabs) and seepage - see photo.
Recommend replacing plumbing drain system.
Recommend having evaluated and corrected by a licensed plumbing contractor.
Estimated cost \$500 - 600

The horizontal cast iron drain pipes in the crawl space have deterioration (rust scabs) and seepage - see photo. Recommend replacing plumbing drain system.

Recommend having evaluated and corrected by a licensed plumbing contractor.

Estimated cost \$500 - 600

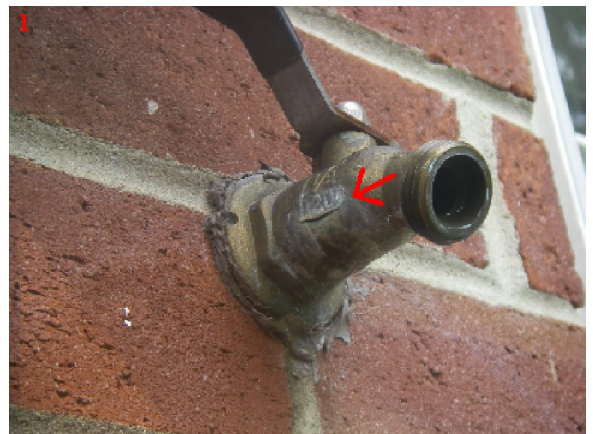
The rear hose bib has a split in the side that leaks when turned on. The split is probably freeze damage. See photo. The hose bib is also missing the required vacuum breaker that prevents accidental back siphoning and potential contamination of the drinking water. Safety concern!
Recommend having plumber evaluate and correct. Estimated cost \$75 - 150

The rear hose bib has a split in the side that leaks when turned on. The split is probably freeze damage. See photo. The hose bib is also missing the required vacuum breaker that prevents accidental back siphoning and potential contamination of the drinking water. Safety concern!

Recommend having plumber evaluate and correct. Estimated cost \$75 - 150

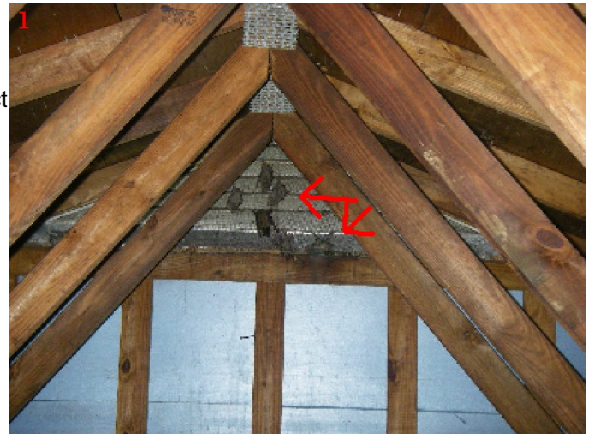
The screen on the gable vent is torn and is allowing bats to enter the attic. See misc. comments below.
Estimated cost to repair screen \$75 - 100

There are "bats" in the attic around the gable vent due to damaged screen on the vent - see photo 1. There is a pile of bat guano (feces) directly under the vent - see photo 2. Bat feces and urine often contain a fungus known to cause a disease called Histoplasmosis. Avoid contact with the bat feces. Professional removal of the bats and clean up is recommended.
Recommend having evaluated and corrected by a qualified professional.

Estimated cost \$150 - 300

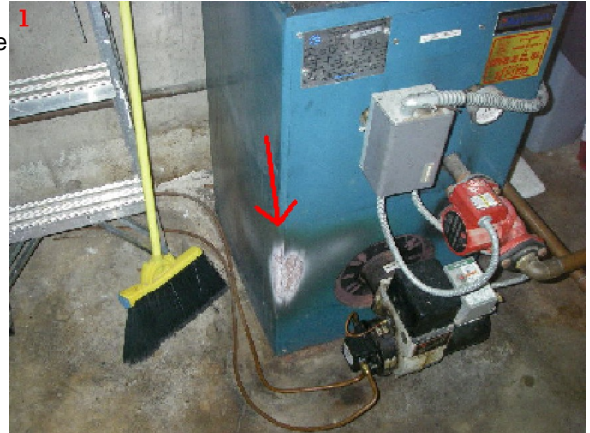
The boiler is missing the required anti back flow valve. Anti back flow valves have been required for safety reason for more than 20 years. The boiler has significant scorch marks on the front left which indicates the burn chamber has failed - safety concern.
Recommend having evaluated and corrected by a Licensed Plumber / Mechanical contractor.
Estimated replacement cost \$3000 - 4000

The boiler is missing the required anti back flow valve. Anti back flow valves have been required for safety reason for more than 20 years. The boiler has significant scorch marks on the front left which indicates the burn chamber has failed - safety concern.

Recommend having evaluated and corrected by a Licensed Plumber / Mechanical contractor.

Estimated replacement cost \$3000 - 4000

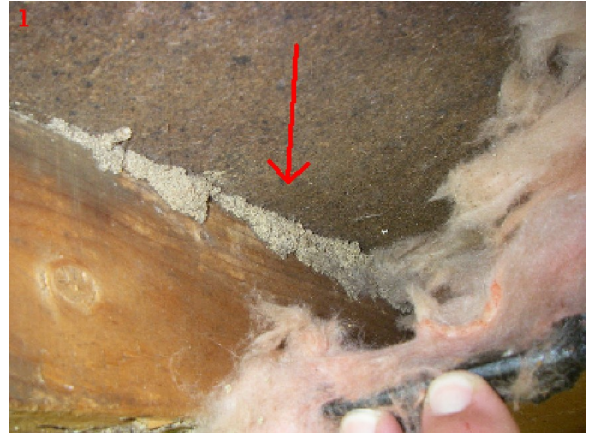
Observed termite mud tunnels on the garage wood framing behind the insulation - see photo. Unable to determine the degree of concealed damage due to installed insulation and plywood. Recommend having further evaluated and repaired by qualified contractors, including a Pest Control Contractor.
Estimated cost \$400 - ??

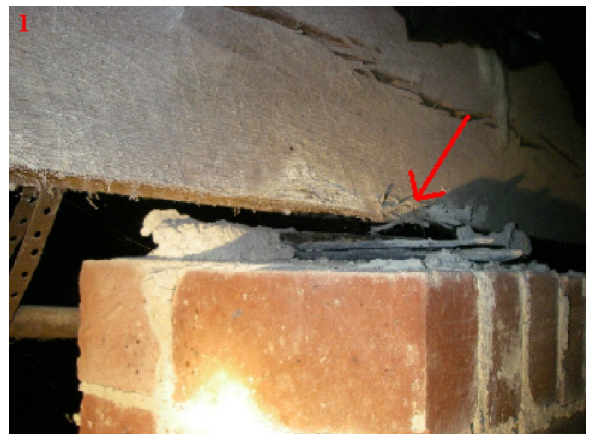
One of the brick piers that supports the center support beam has settled down 1 inch leaving a space between the beam and the pier.
Recommend having evaluated by qualified engineer and/or qualified foundation repair contractor and have corrected as necessary.
Estimated cost \$450 - 600

One of the brick piers that supports the center support beam has settled down 1 inch leaving a space between the beam and the pier. Recommend having evaluated by qualified engineer and/or qualified foundation repair contractor and have corrected as necessary.
Estimated cost \$450 - 600

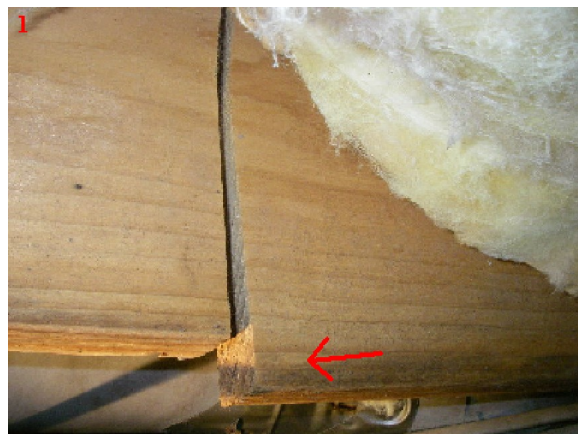
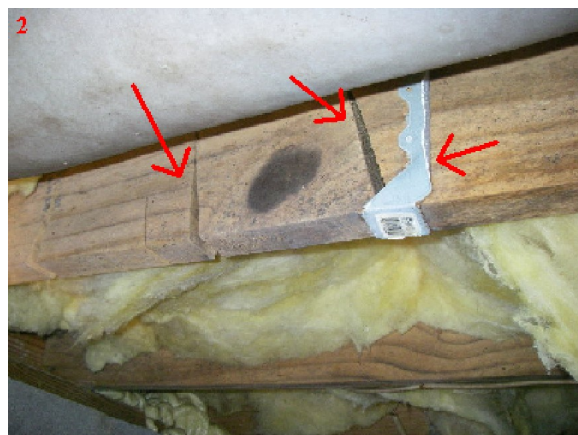
The left rear bedroom floor structure has a significant structural deficiency including numerous cut joists and amateur inadequate repairs - see photos.
Recommend having evaluated and corrected by a qualified contractor.
Estimated cost \$500 - 700

The left rear bedroom floor structure has a significant structural deficiency including numerous cut joists and amateur inadequate repairs - see photos.

Recommend having evaluated and corrected by a qualified contractor.
Estimated cost \$500 - 700
