Cranor Inspection Services, LLC.

Client Information: Record Number Sample

Smart, Max
100 Good Street
Richmond , VA
804-873-8534

Type and Scope of Inspection

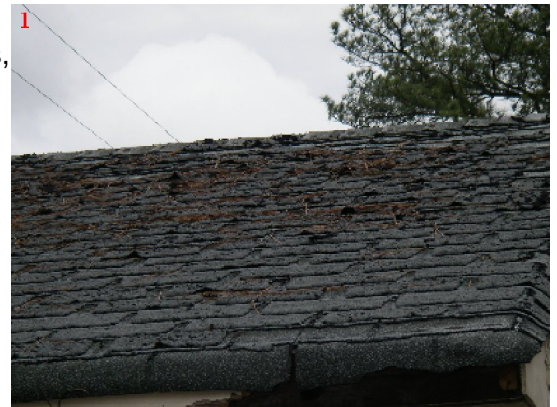
Roof Covering Condition (Main) - Roof covering appears to be worn out

The shingle roof is showing indications of advanced age (worn out) - shingles are brittle and crumbling, excessive granule loss, missing pieces, etc. Observed active leaking in attic is several spots. Roof will require immediate replacement.

The shingle roof is showing indications of advanced age (worn out) - shingles are brittle and crumbling, excessive granule loss, missing pieces, etc. Observed active leaking in attic is several spots. Roof will require immediate replacement.
Estimated cost \$5000 - 5500

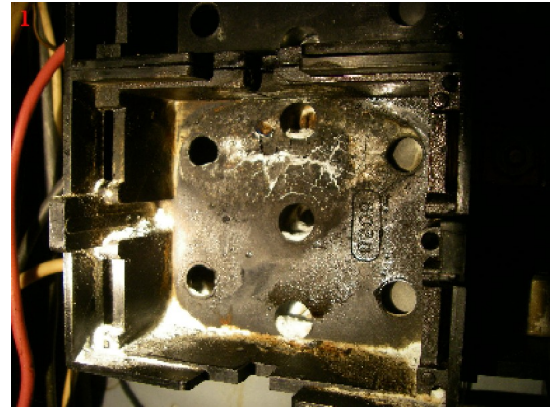
Service / Distribution Panel - 120 / 240 Volts, 150 Amp, Fuses, Located in Utility Room, No main disconnect

The fused electrical panel has a hazardous condition. Behind the pull out fuse block there is corrosion and symptoms of over-heating. The electrical panel will probably have to be replaced. Electrical system requires immediate attention for safety reasons!

Recommend having electrician evaluate and correct - Estimated cost \$1000 - 1500

Recommend having electrician evaluate and correct -
Estimated cost \$1000 - 1500
