Inspection Report

Inspected Property: 123 Sunny Sky St, Glen Allen,VA, 23838 Client: Maxwell Smart (804) 873-8534, john@cranorinspections.com Real Estate Agent: -

> Date of Inspection: 10/1/2019 Time: 9:00 AM Year Built:2019 Size: 2900 sf Fee: \$300.00

PRE DRYWALL INSPECTION

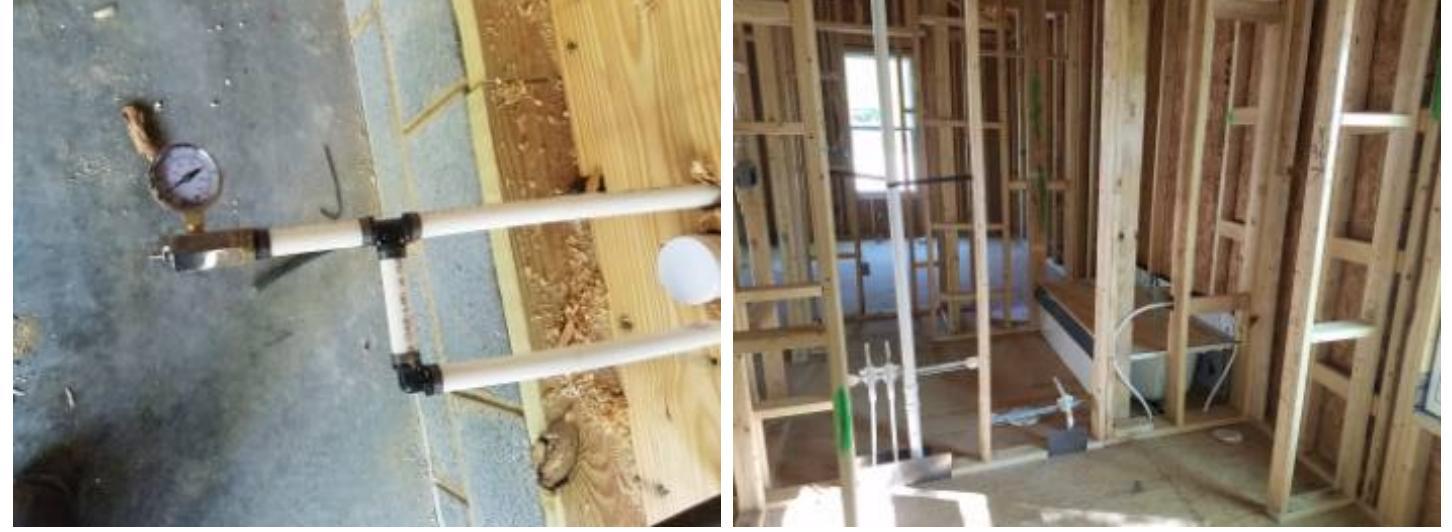
plumbing pressurized and holding

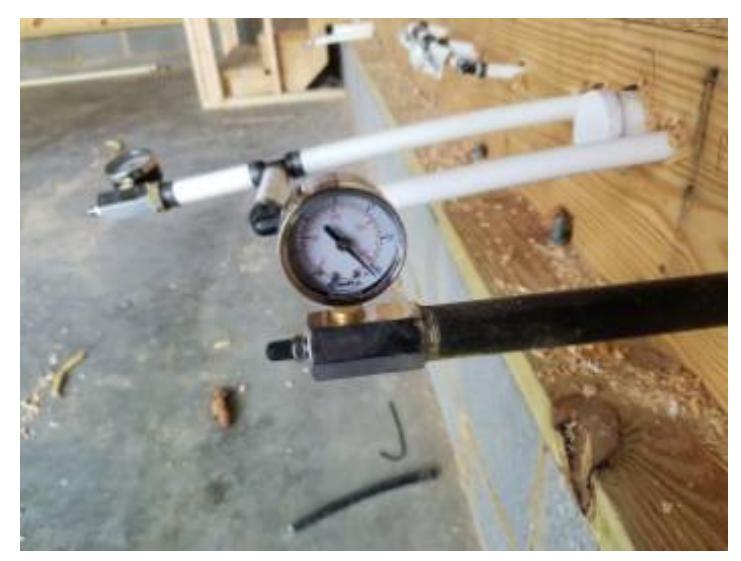
gas system pressurized and holding

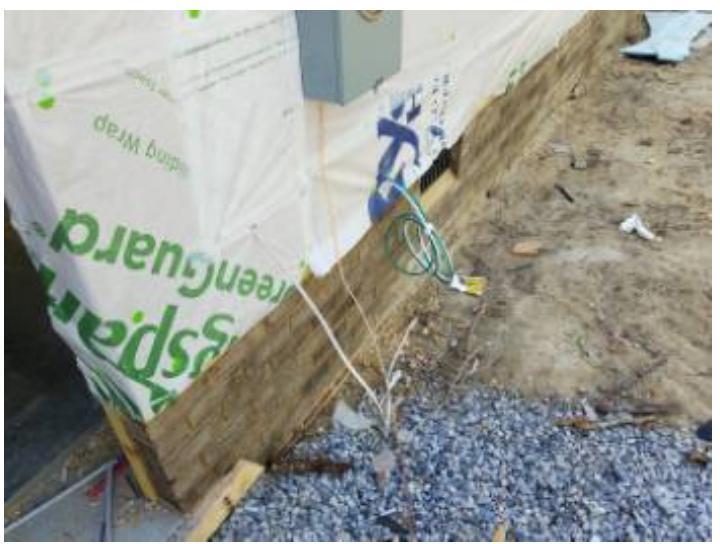
2.1. Grounding not yet complete

grounding not yet complete

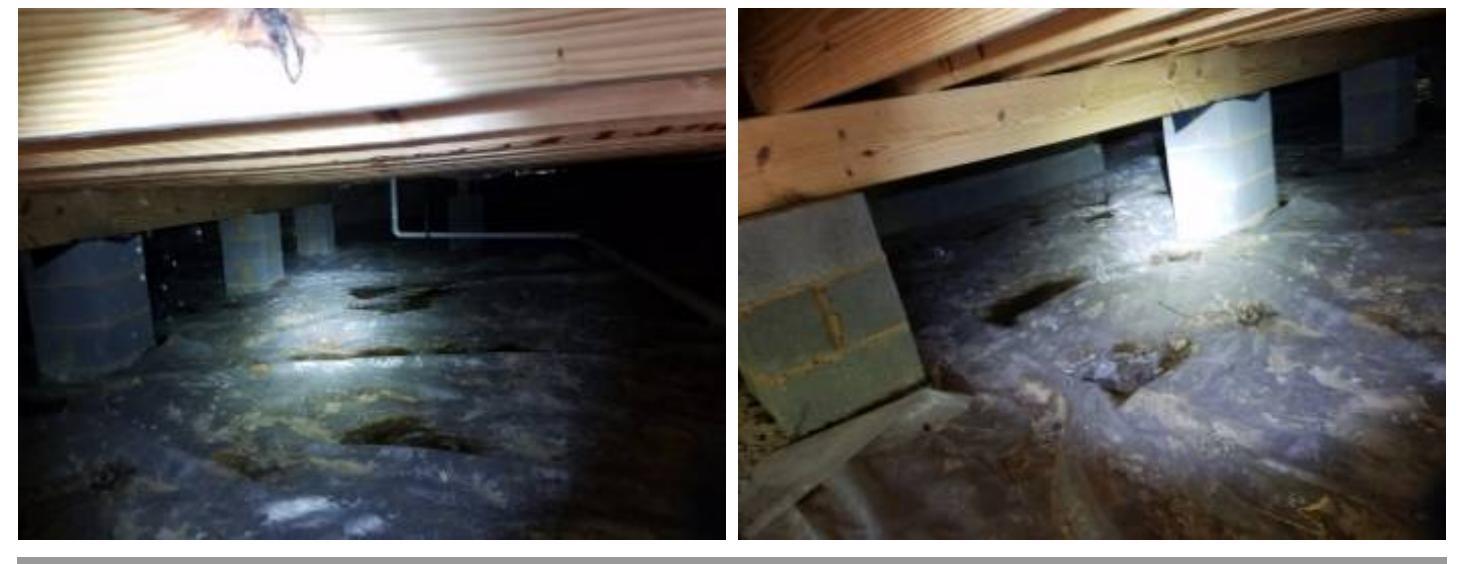
4.1. Currently there are numerous puddles of water laying in crawl space. Recommend immediate removal of water before mold growth occurs. Some of the ground is not fully covered with a poly vapor barrier. All exposed dirt should be covered.

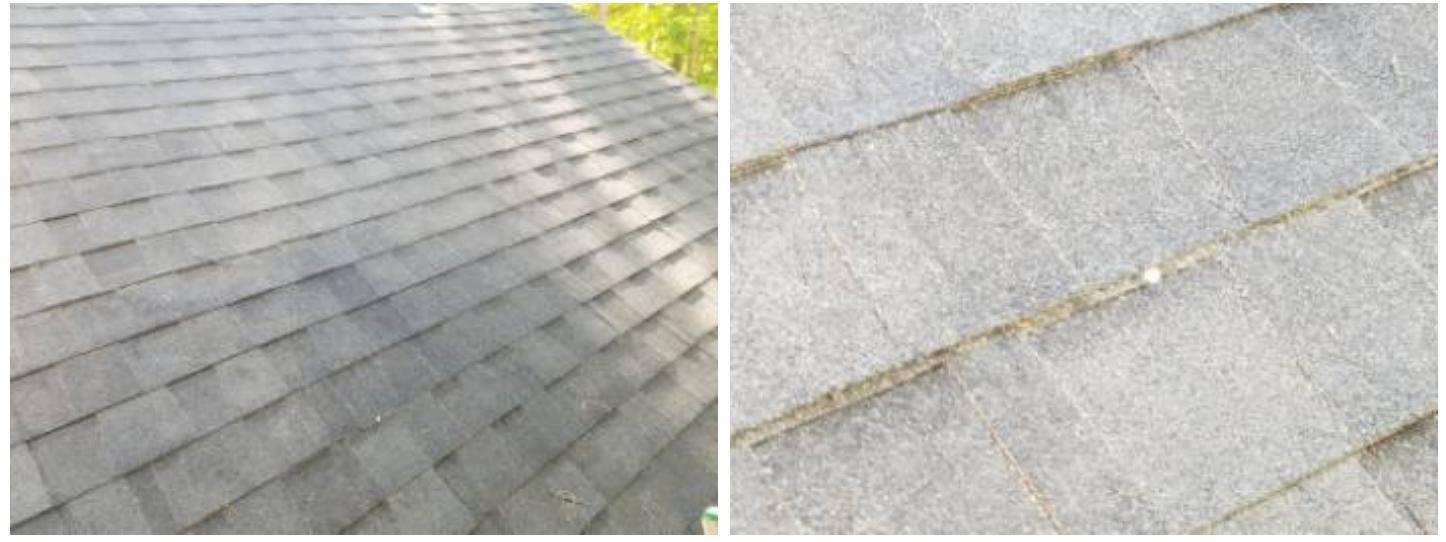
2.1. Currently there are 4 or 5 cables sticking out of the roof from under the shingles. The cables are typically used for tying off the roofers while they install the roofing. The cables should be removed and any damaged shingles replaced. (Note: Some builders leave them in until the house is fully complete and some leave them until the end of first year). There are a few scattered exposed nails where they were driven into the shingles below the nail line. All exposed nails should be corrected. The shingles were cut in the valley too far out of the center. Some are cut out as much as 4 inches. The closed-cut valley should have shingles cut out of the center approximately 2 inches but 3 or 4 inches is too much. Recommend correcting.

exposed nail on lower rear right

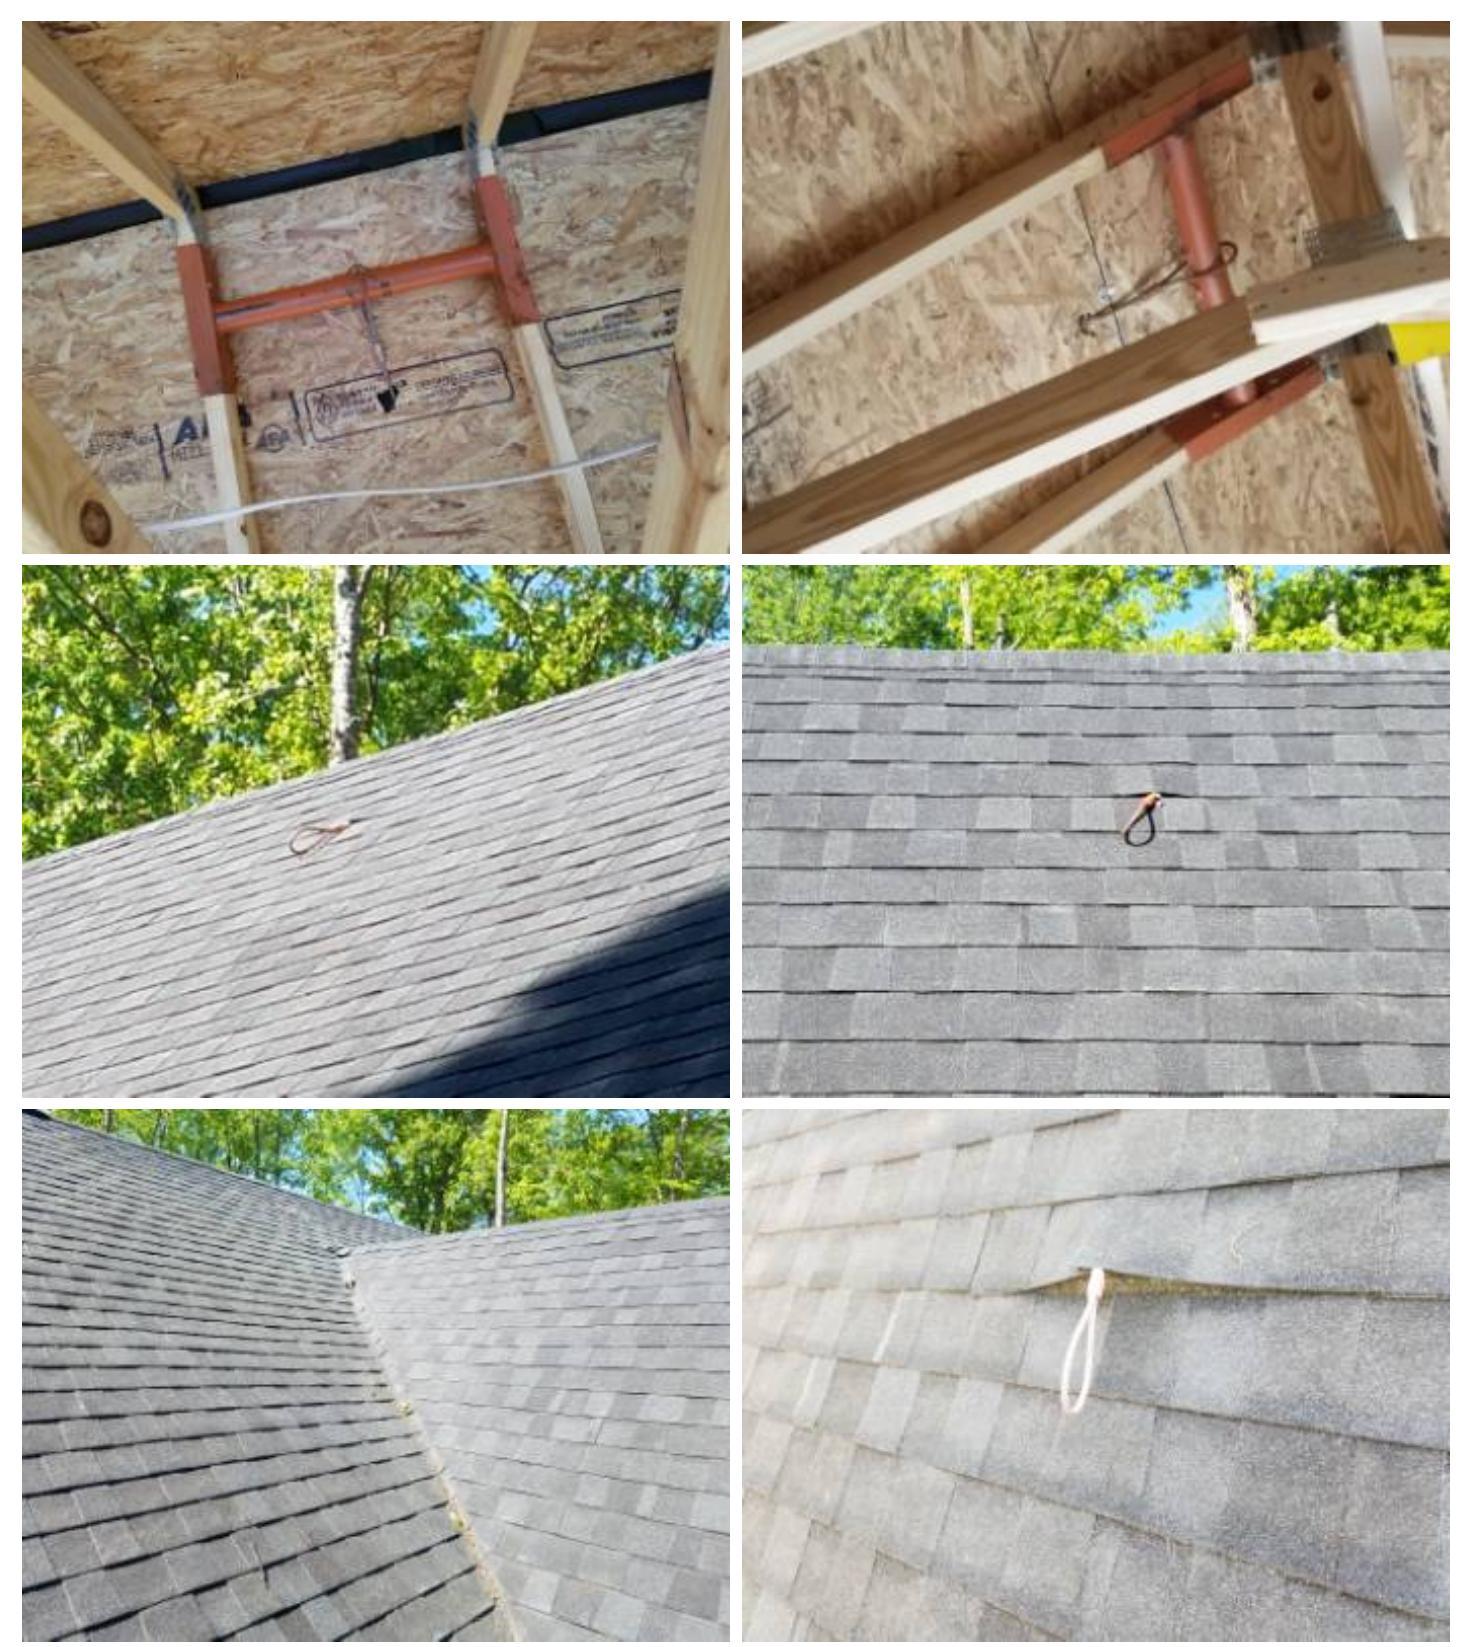
valley cut out of the center too far / 4 inches is too much

exposed nail
