29 OBX Dr, Henrico, VA 23233 Inspection prepared for: Real Sample Real Estate Agent: No Agent -

Date of Inspection: 11/30/2016 Time: 9 - 12 PM Year Built: 38 yrs Size: 2330 sf Paid \$

Inspector: John Cranor VA Certified Home Inspector #3380000119 Exp.10/17 PO Box 1455, Glen Allen, VA 23060 Phone: 804-873-8534 Email: cranorinspectionservices@gmail.com House-Whisperer.com (M) TheHomeInspection.com

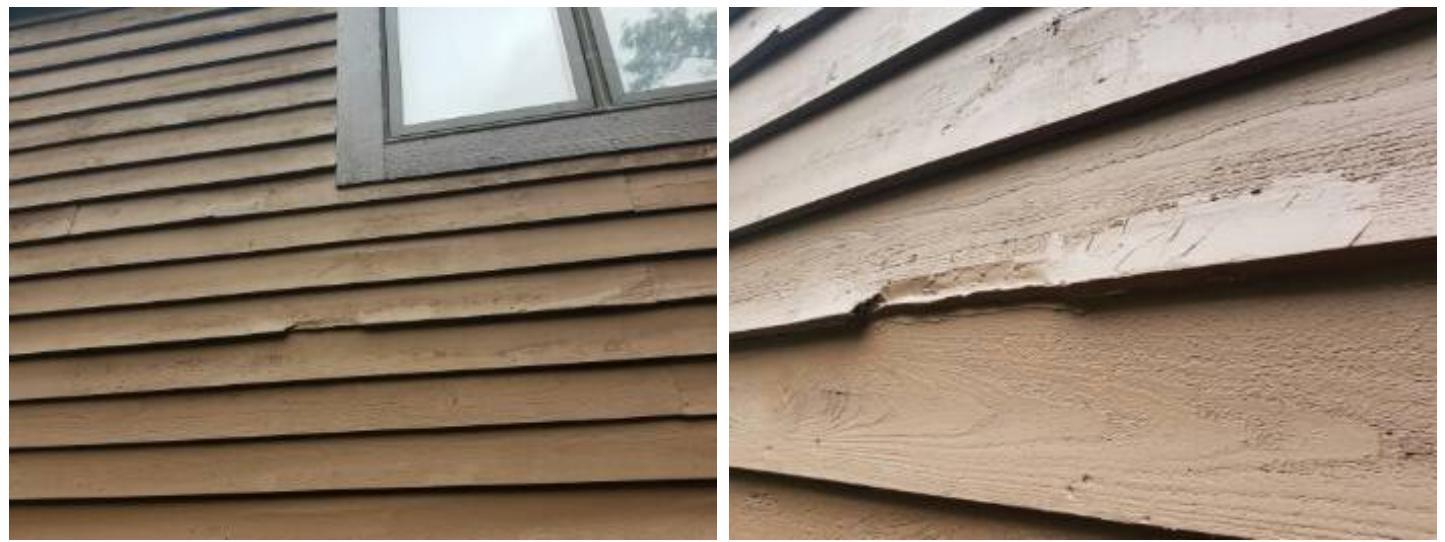
1.1. The wood siding has had deferred maintenance in the past and as a result there have been extensive patching on damaged boards. The patching is rough. There are countless damaged areas that have not been patched and many areas that have been patched are inadequate. The overall siding condition is extremely poor. Water penetrating through into the interior wall is highly likely in many areas. Recommend complete replacement of the siding and all trim. Recommend obtaining estimates from licensed contractors to replace. Estimated Cost \$20,000 - ??

damage

damage / patching

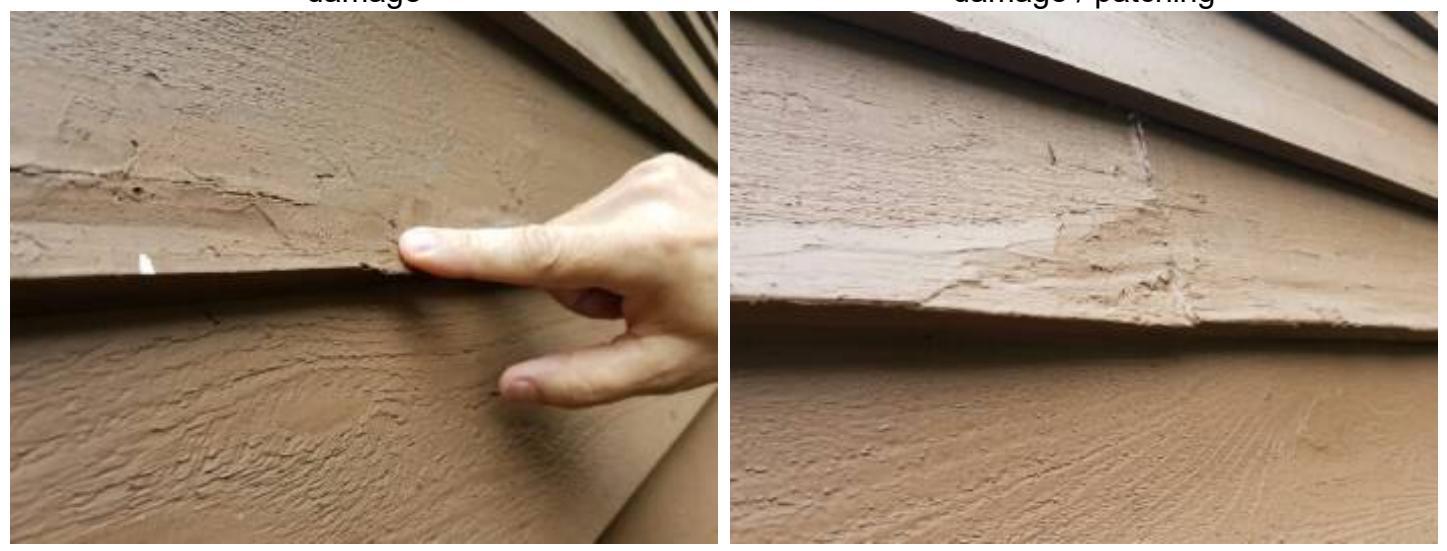
patching and rot

patching

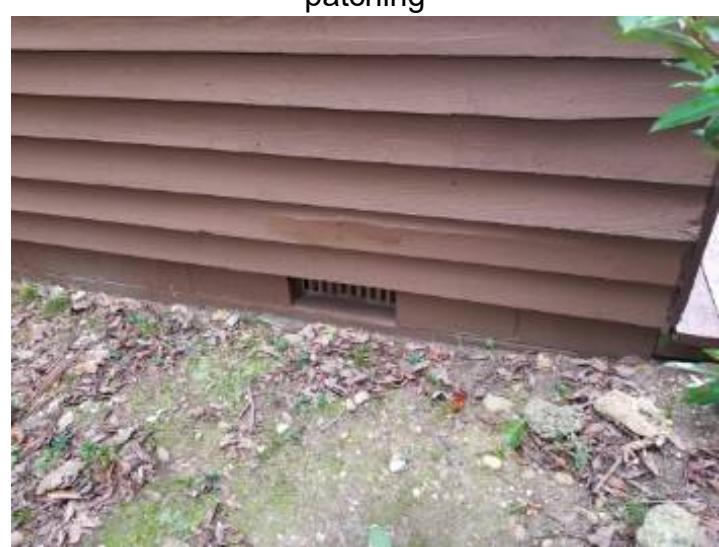
split / damaged / patch

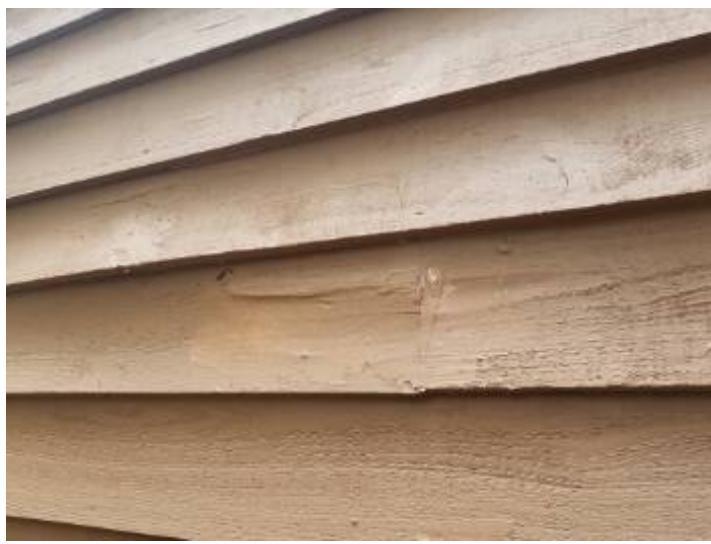
patched

damaged siding

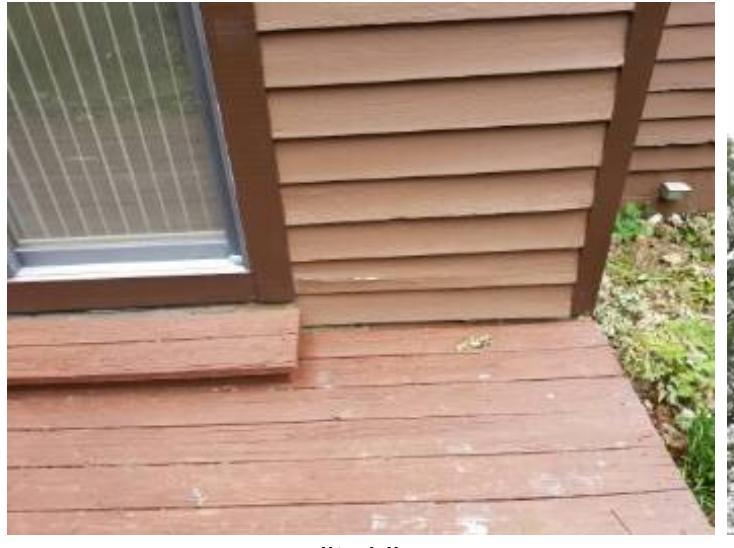
split siding

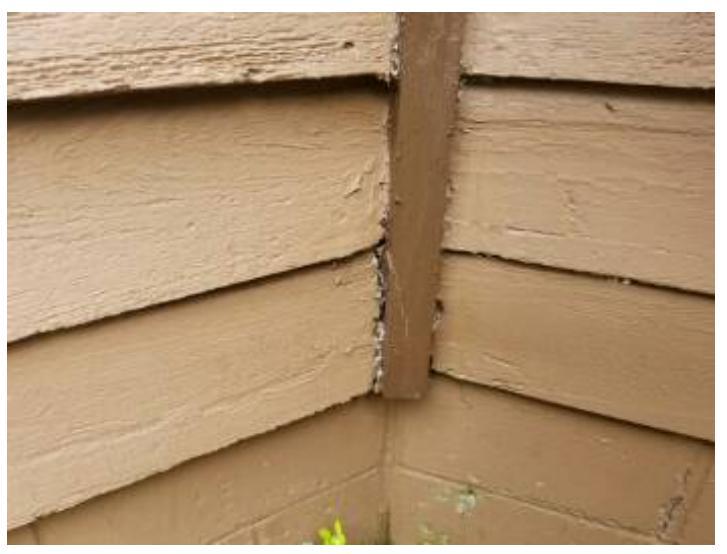
damage

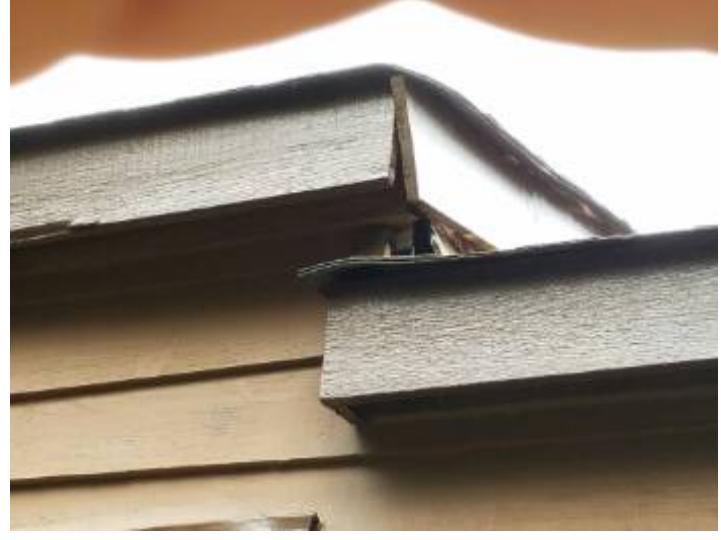
missing piece of siding near roof eave

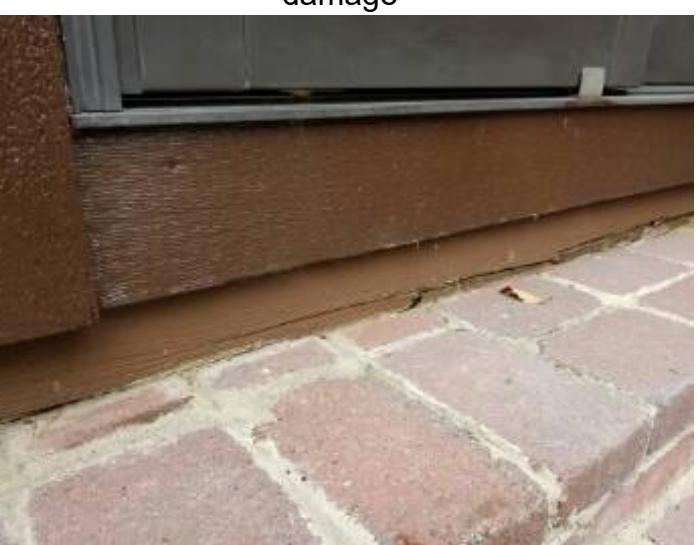
open gaps around doors

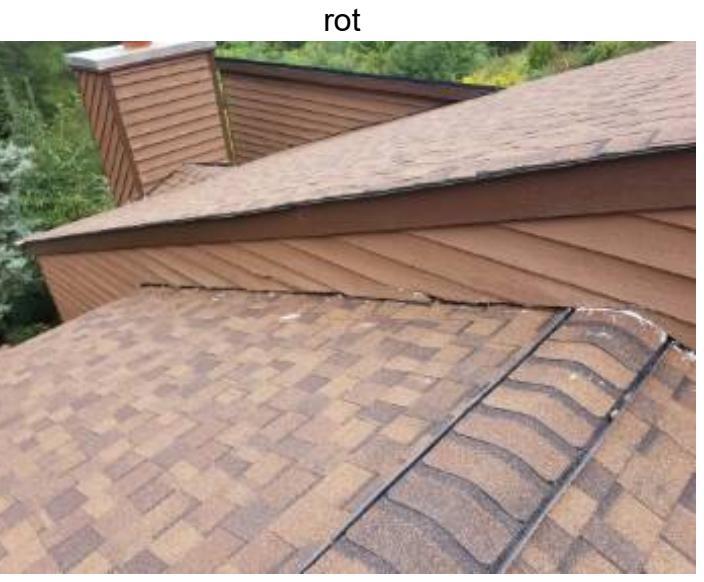
siding damage all along the roof

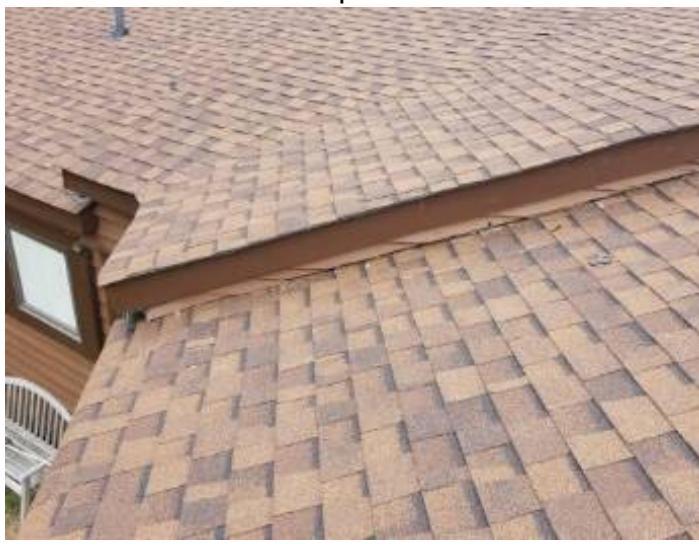
siding damage all along the roof

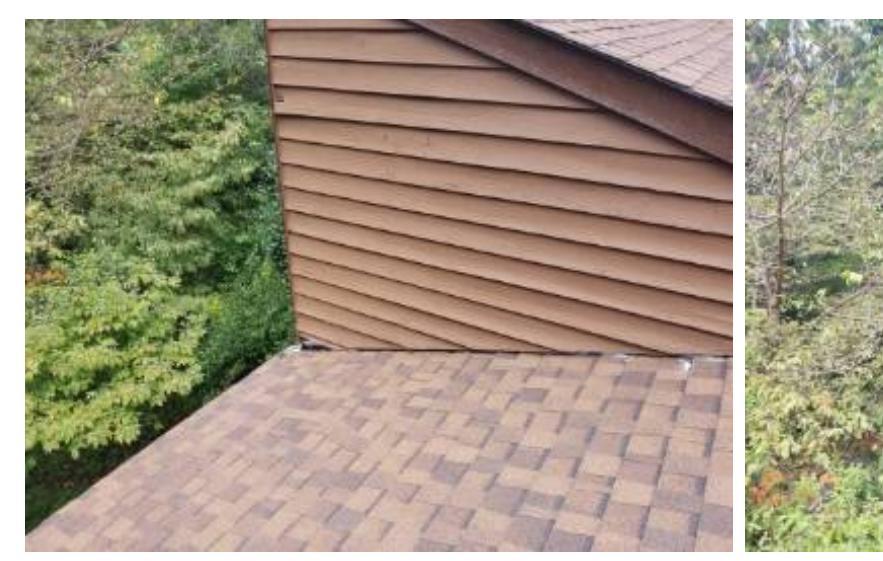
siding damaged / in poor condition above the roof siding damaged / in poor condition above the roof

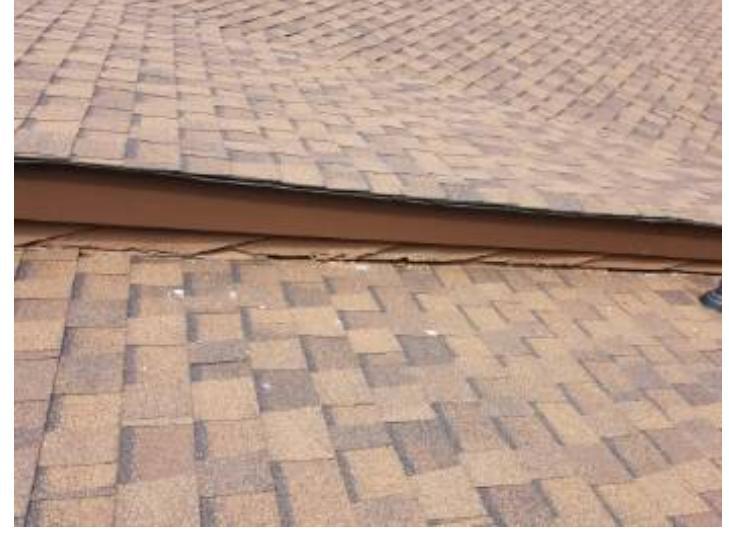
siding damage all along the roof

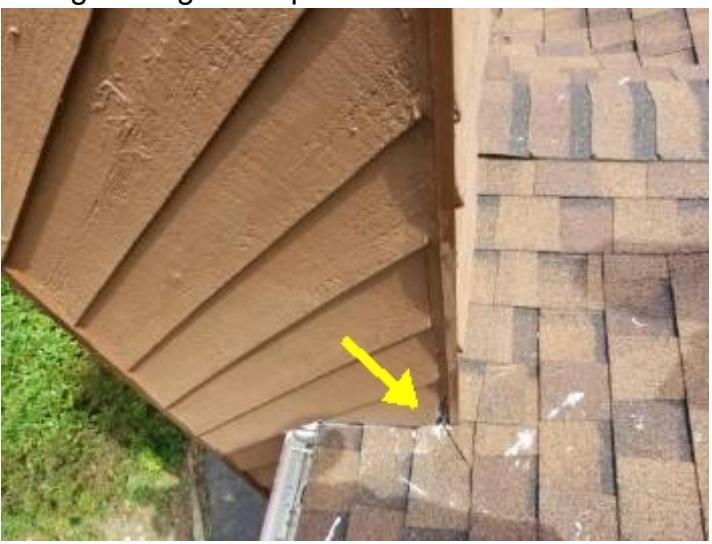
damage on chimney above roof

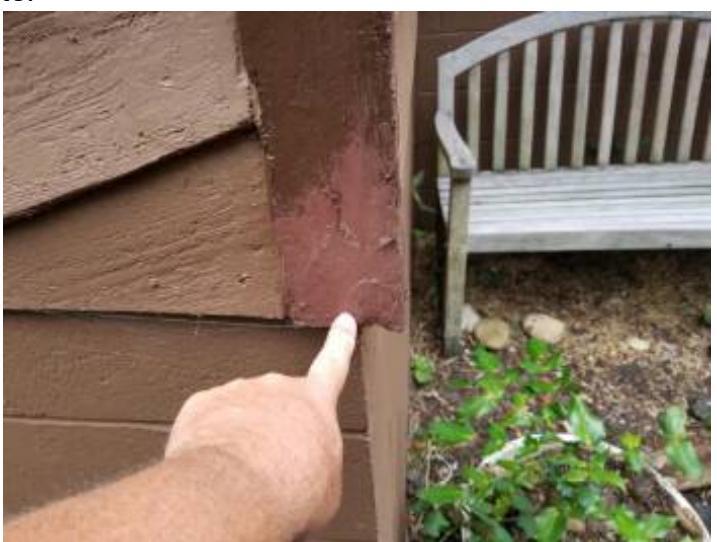
2.1. The wood trim around the house is weathered and in overall poor condition as is the siding. The inside corner trim near the electric meter has extensive damage (rot). The corner trim on front has rot. All trim should be replaced during the replacement of the siding. See siding comments.

rot on front corner trim

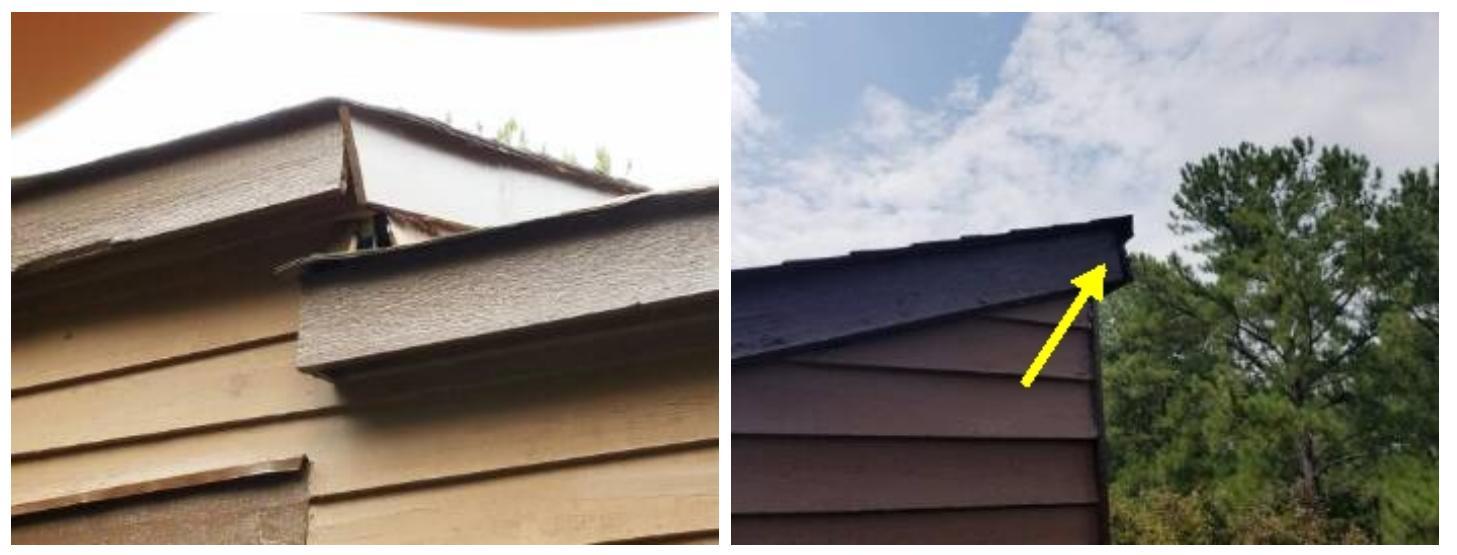
3.1. The wood eaves are weathered and has scattered damage. The wood eaves are in overall poor condition and replacement is recommended. See siding comments.

open gaps in eave / poor condition

damaged

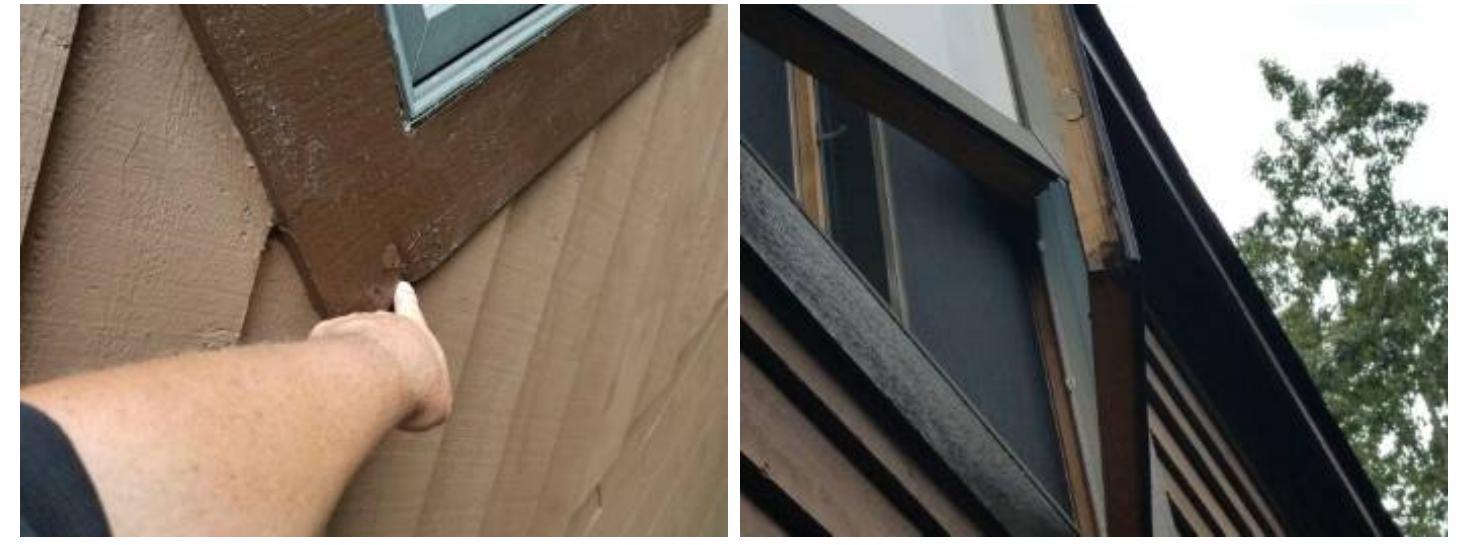
4.1. Damage (rot) on window trim on front right. Estimated Cost \$150 Window trim should all be replaced when replacing the siding.

4.2. There are moisture penetration stains visible on many windows which will eventually cause damage (rot). Also observed on inside around the stationary windows moisture stains which indicates the windows are leaking. Recommend having further evaluated by a licensed qualified window contractor. Stopping water leakage around the old windows may be difficult and replacing windows may be the only reliable solution. Estimated Cost to replace windows \$5000 - ??

rot on front right

moisture seeping in on right

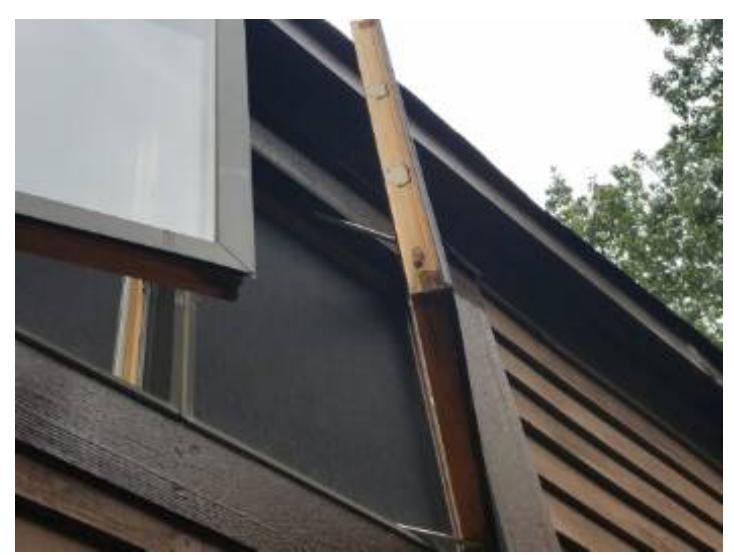
moisture seeping in on right

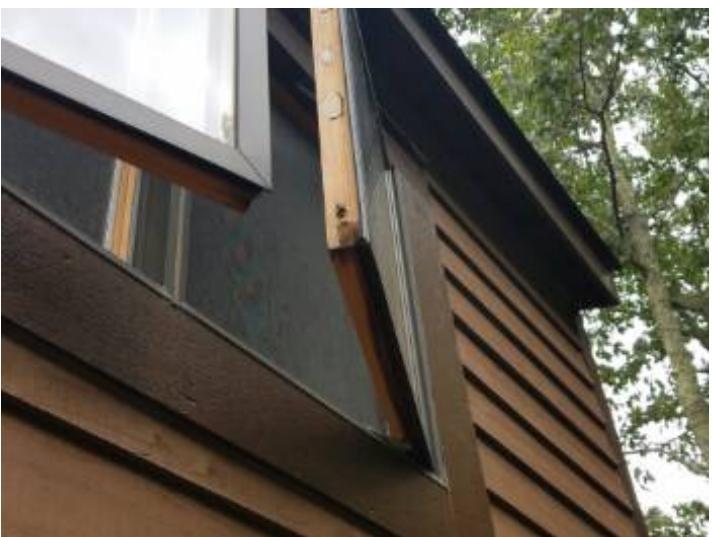
moisture seeping in on right rear

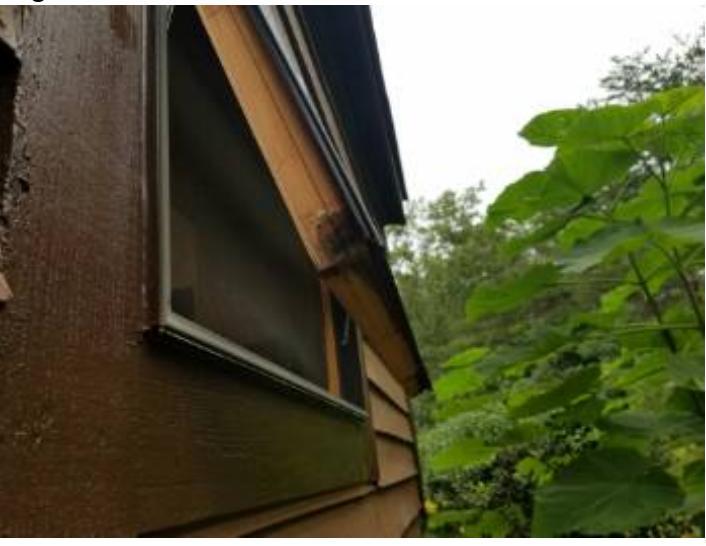
moisture seeping in on left awning window

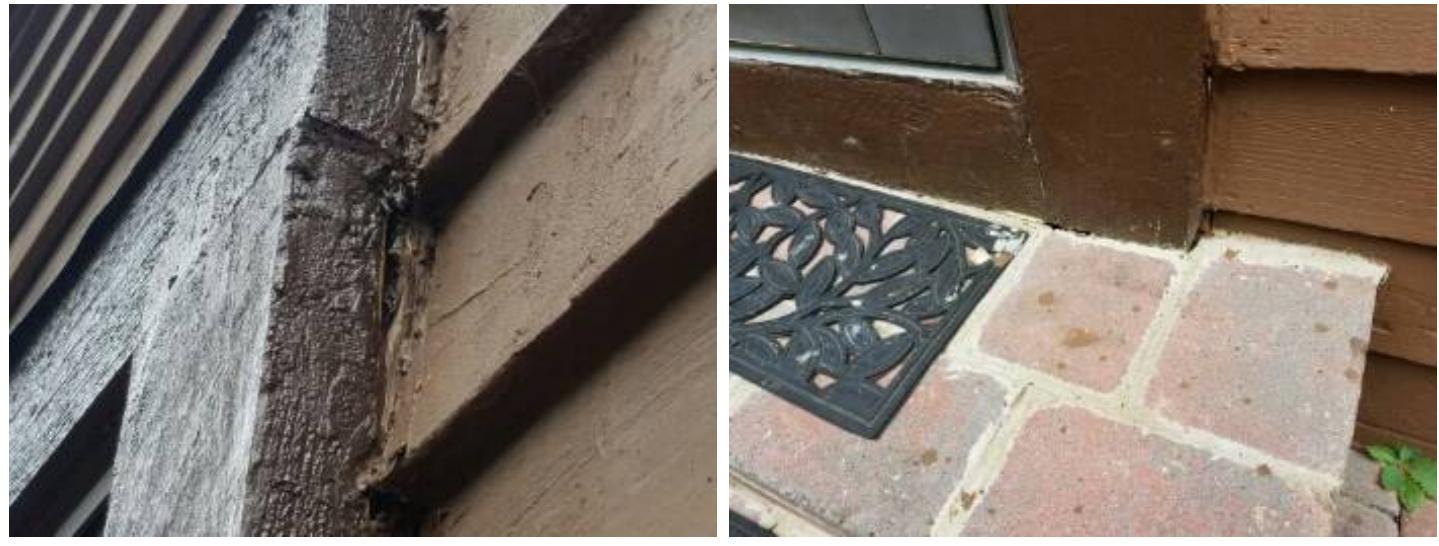
6.2. There are open gaps all around the doors where the siding is missing, not caulked and/or improperly repaired. Estimated Cost \$150 - 200

open gaps around doors

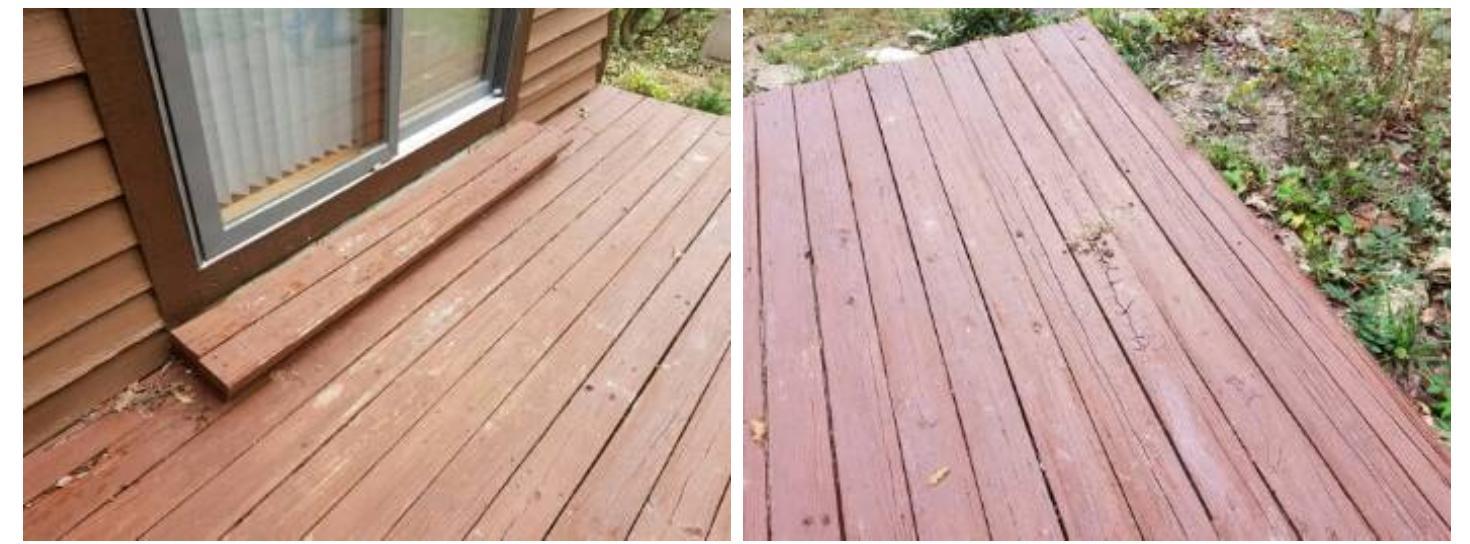
8.1. The decking is weathered. Recommend immediate maintenance.

8.2. The step on deck at sliding door is loose and unstable. Estimated Cost \$100 - 150

loose / unstable step

deck is weathered

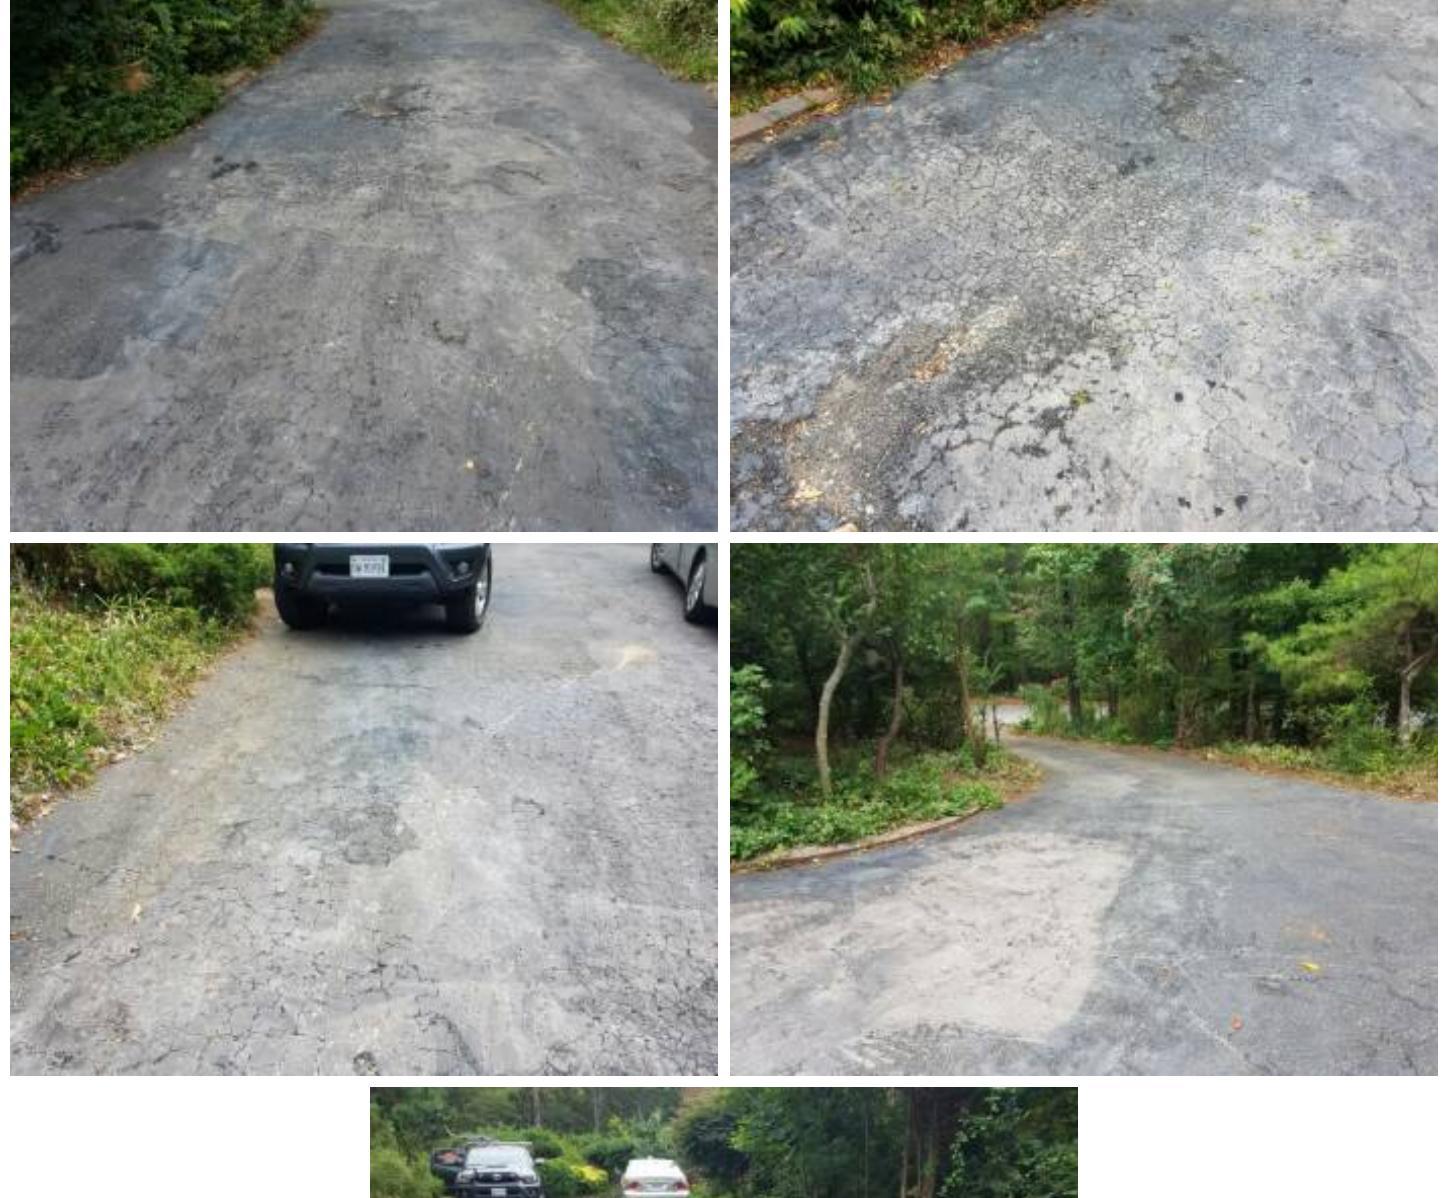
10.1. The driveway is cracked and deteriorated which is typical of an old asphalt driveway. Usable but in poor condition

poor condition

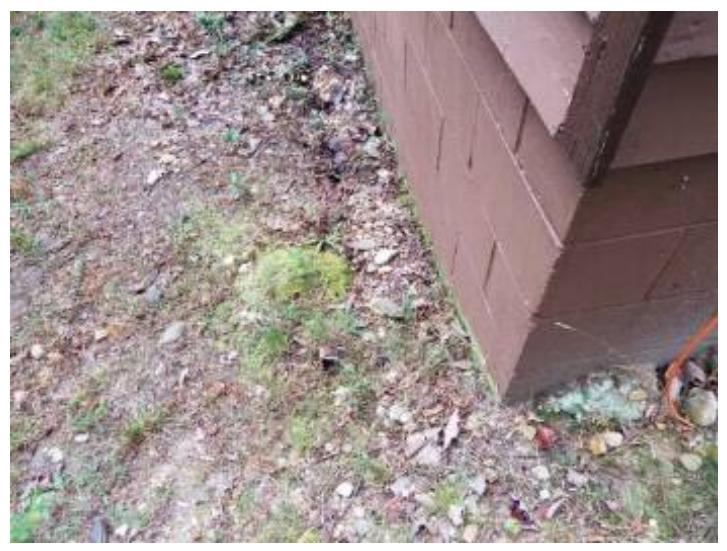
12.1. Trenching and soil erosion around perimeter of home due to lack of gutters. Recommend regrading so surface water drains away from the foundation. The grade should fall a minimum of 6 inches within the first 10 feet. Recommend adding gutters to help control water. Estimated cost to improve \$450 - 650

trenching

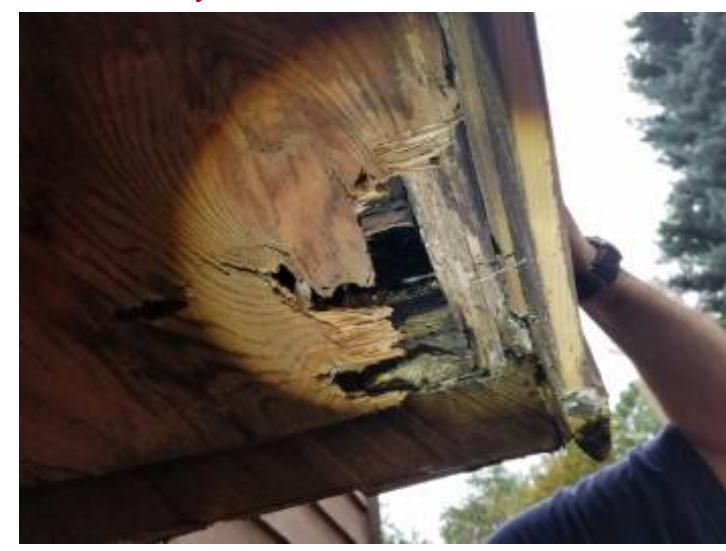
14.2. The cantilever fireplace offset has extensive moisture damage (rot) on bottom that appears to extend upward. I suspect the water is entering on top of chimney and running down. See siding and chimney comments. Estimated Cost \$350 - 450

extensive rot on bottom of fireplace offset

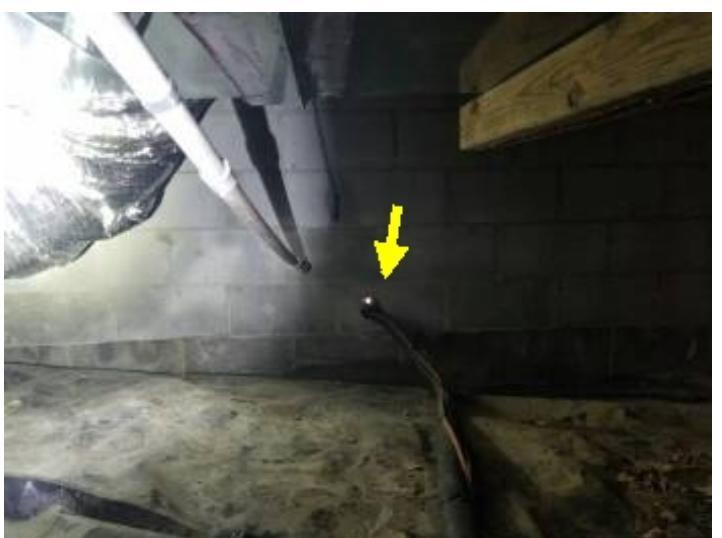
14.1. Observed open gaps around the heat pump lines where they penetrate the foundation wall. Recommend sealing around pipes to prevent moisture, air and/or vermin from entering. Estimated Cost \$75

open gap observed from crawl space

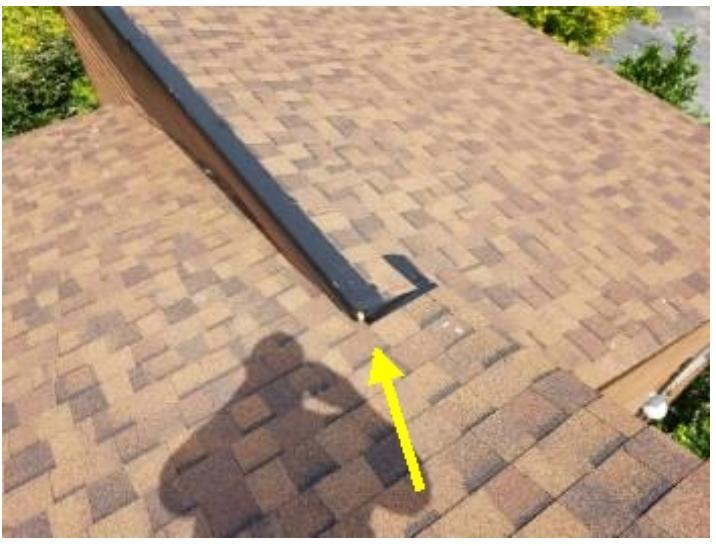
4.1. Exposed wood on roof. See photo. Estimated Cost \$75

exposed wood

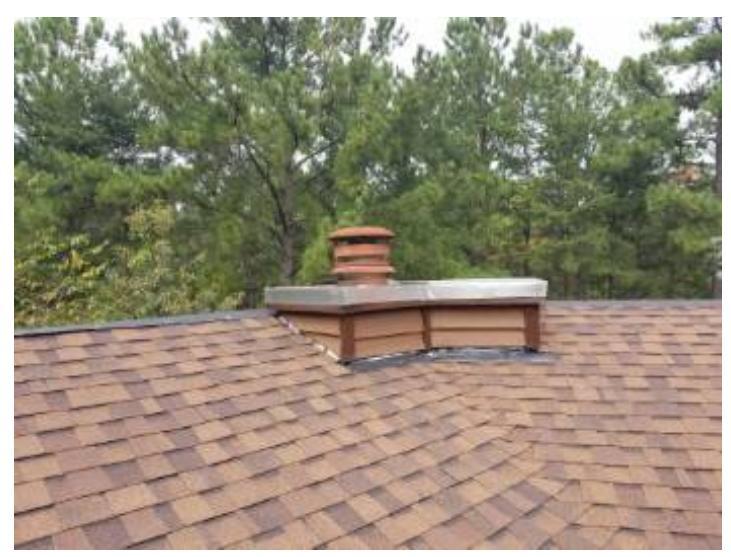
5.1. The living room fireplace chimney termination is too short. A chimney must be at least 2 feet taller than any structure within 10 feet of it and also at least 3 feet higher than the point at which it penetrates the roof. A chimney that is too short is unlikely to vent properly and it may also be a serious fire hazard to the building, risking setting the roof on fire. Recommend correcting for safety reasons. Estimated Cost \$500 - ??

chimney too short / must extend above roof at least 2 feet

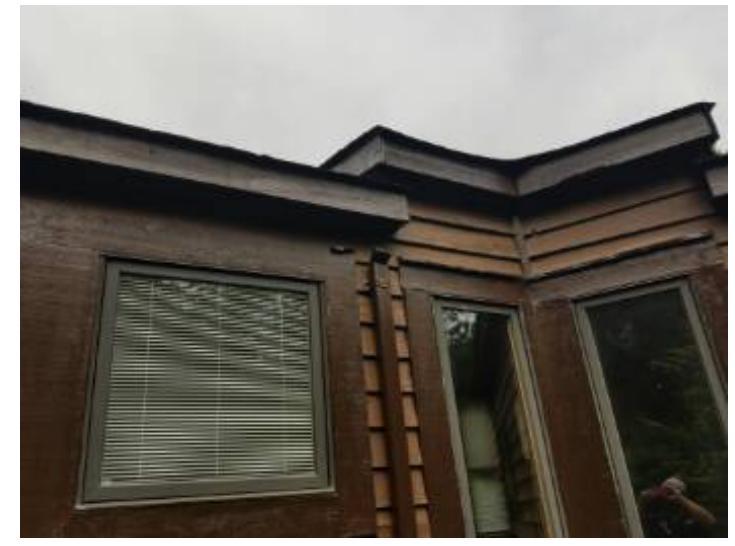
6.2. The gutters have been removed but one of the down spouts was left in place. Gutters are not a requirement but are strongly recommended to help control water. Recommend re installing gutters. Estimated Cost \$2500 - ??

gutter has been removed but down spout left in place

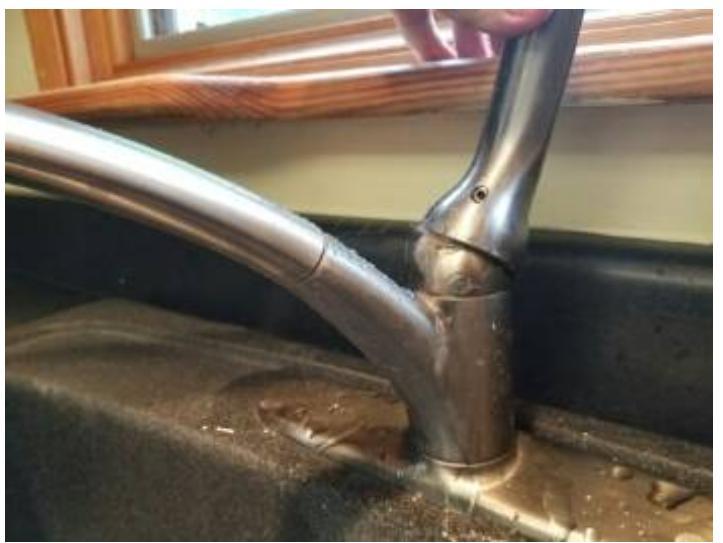
1.1. Plumbing fixture is leaking around handle. Estimated Cost \$150 - 350

leaking

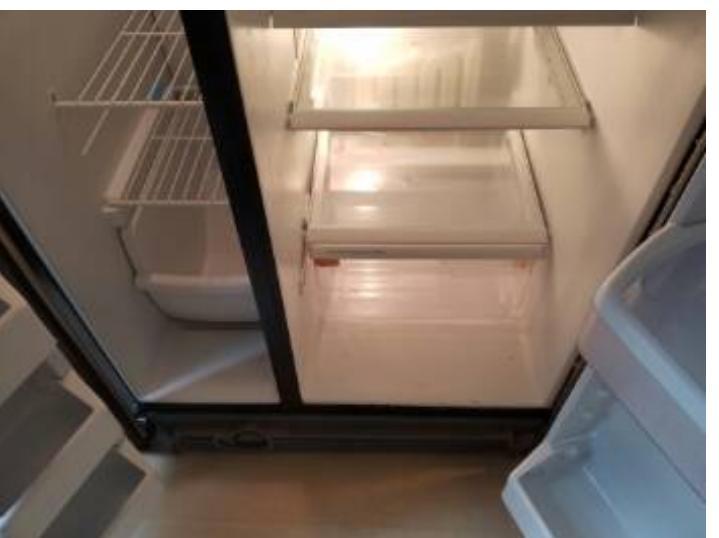
4.1. The refrigerator has cracks and damage on inside and the door is dented.

damaged refrigerator

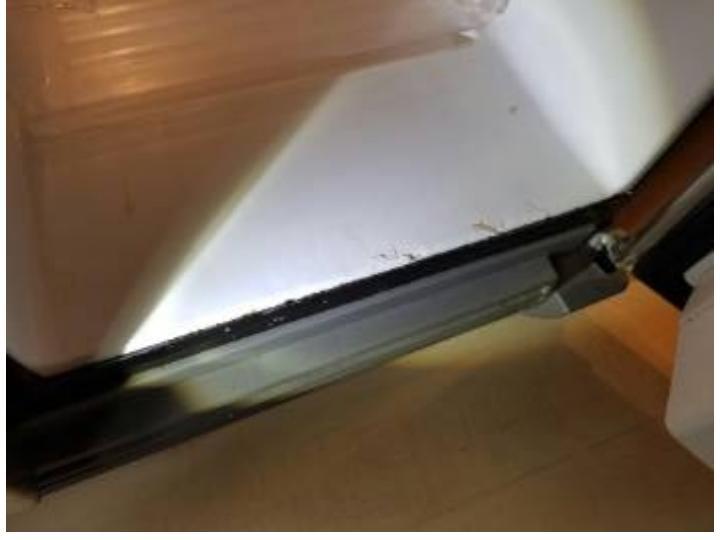
damaged refrigerator

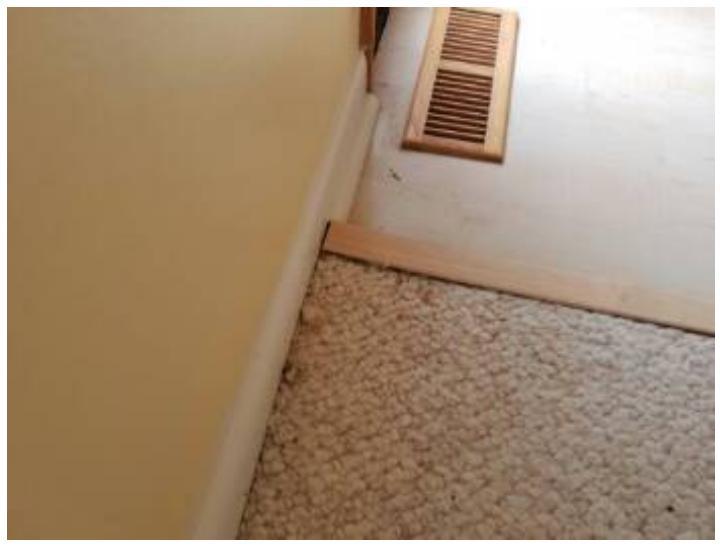
- 5.1. Ceiling patches
- 5.2. Loose floor transition strip in kitchen. Estimated Cost \$75

loose transition strip

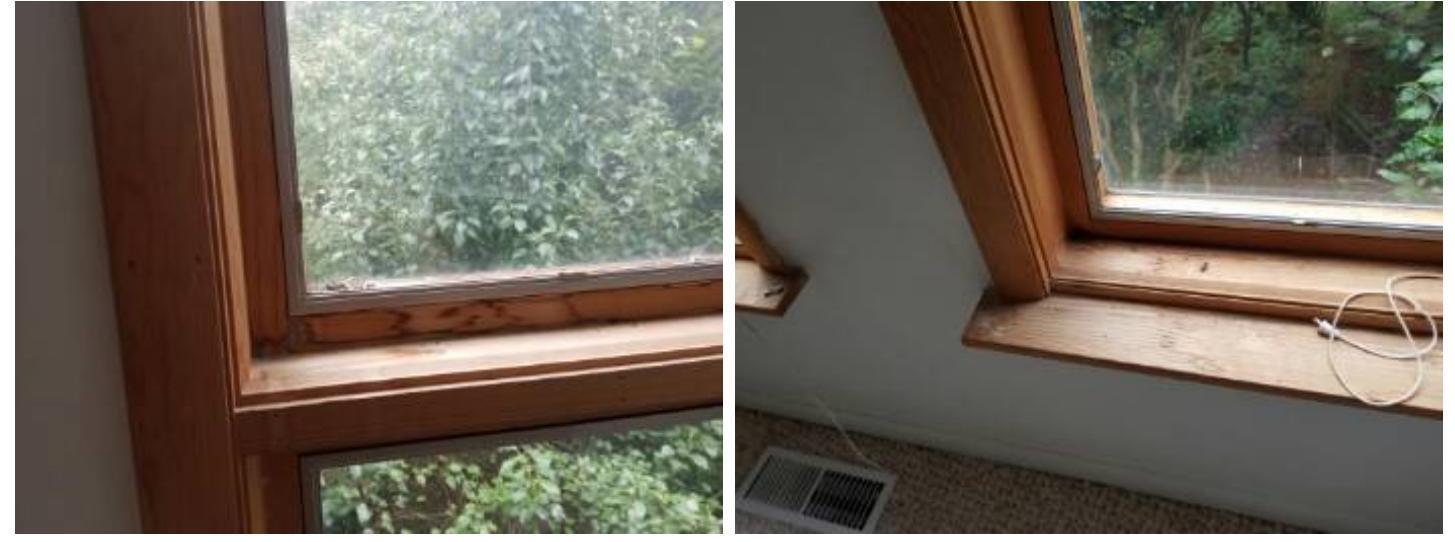
2.1. Moisture stains visible around several stationary windows which indicates the windows leak. See exterior window comments.

stains on inside of stationary window

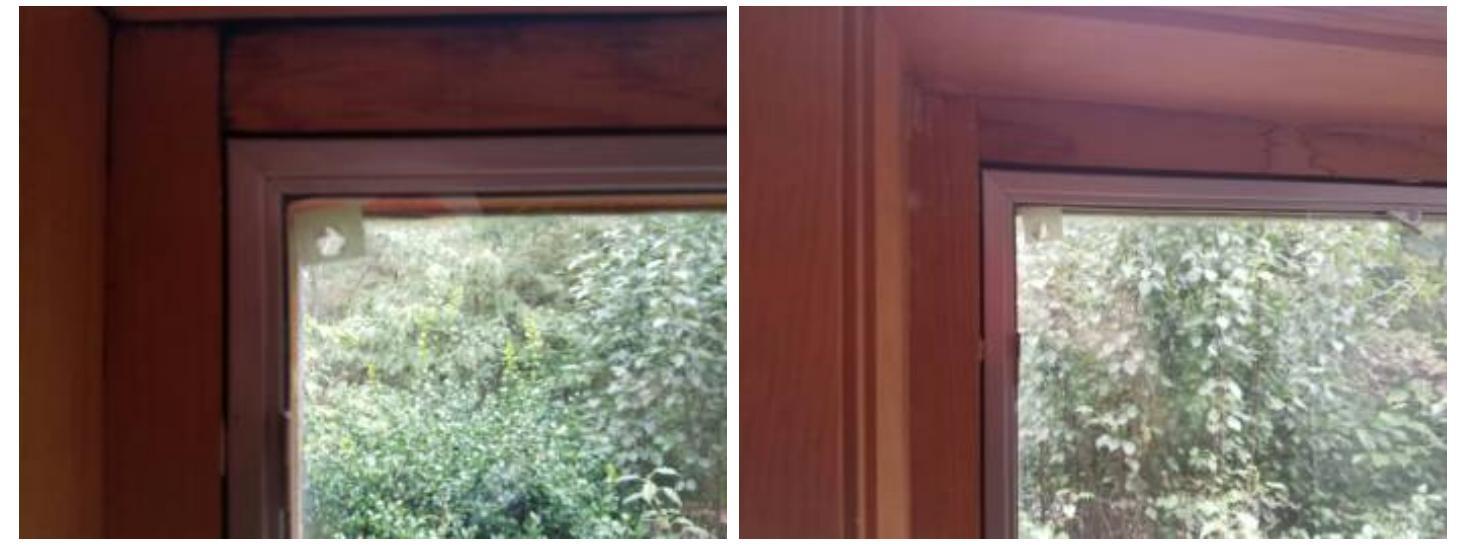
2.2. The double glazed windows have breather holes in the tops of the inside panels which are designed to allow trapped moisture between the outer and inner glass panels to escape. The breather holes are supposed to have little plugs in each hole. Many are missing. Recommend contacting Pella Window Company about replacing the plugs. Estimated Cost \$??

breather holes missing plugs

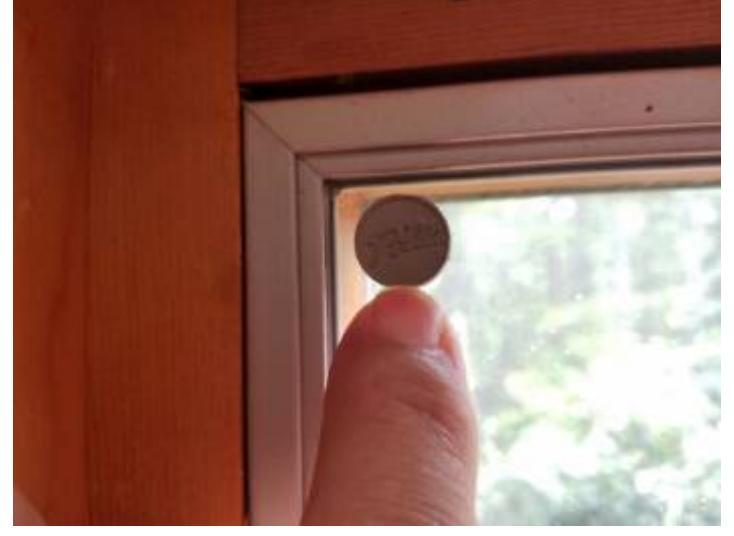
plug that is missing in many windows

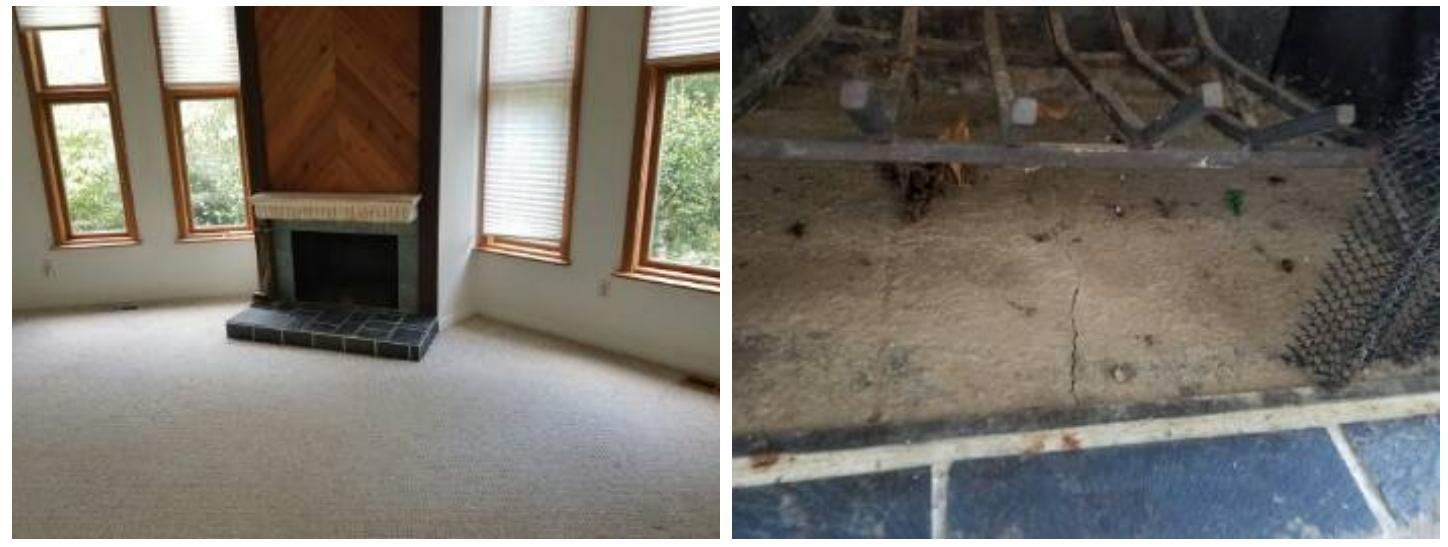
1.2. The refractory panel in bottom of fireplace firebox is cracked. Recommend replacing panel. Estimated Cost \$250 - ??

crack in bottom refractory panel

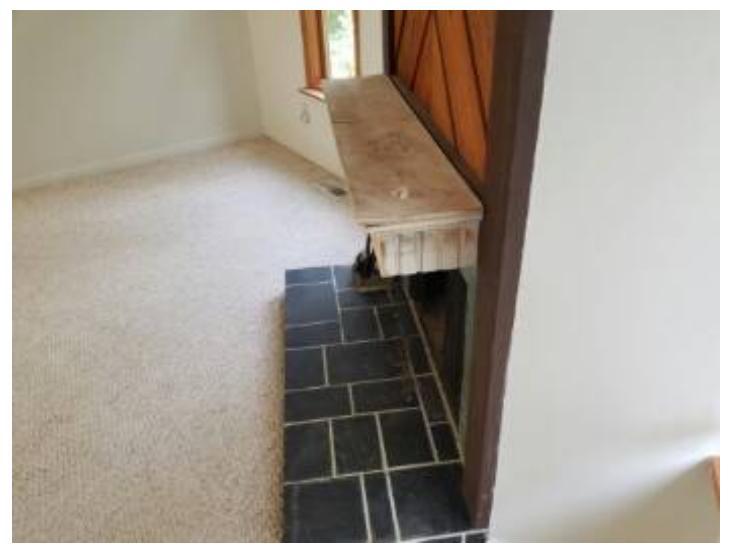
wood mantel too close / unsafe

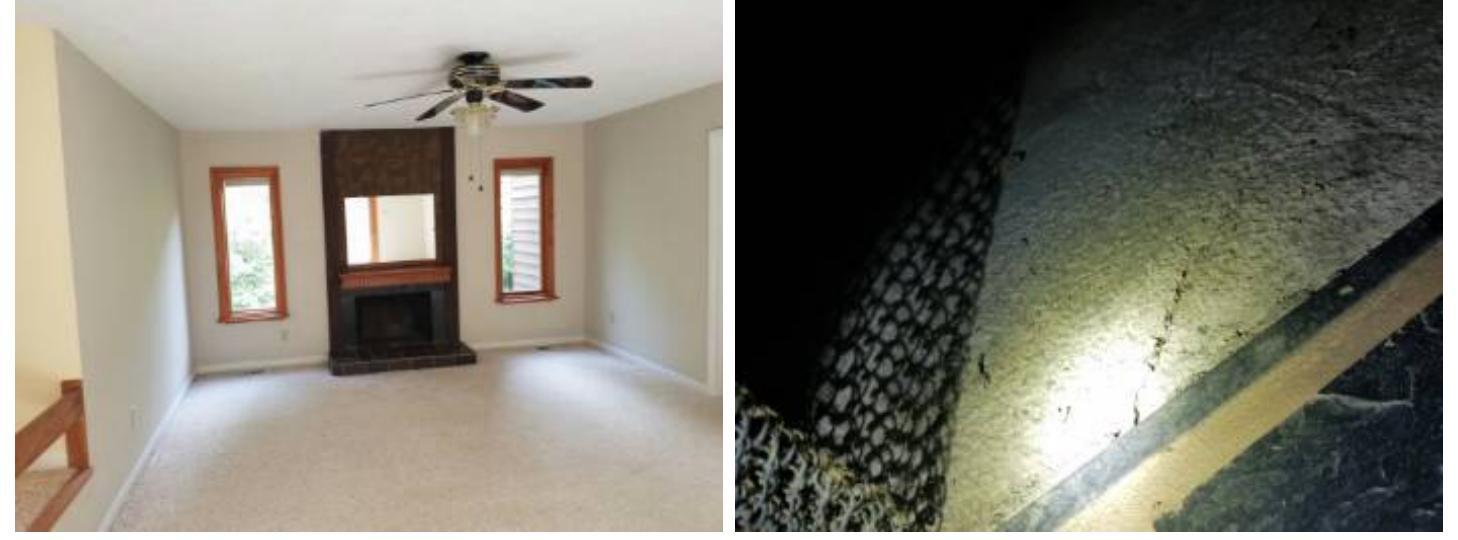
crack in bottom refractory panel

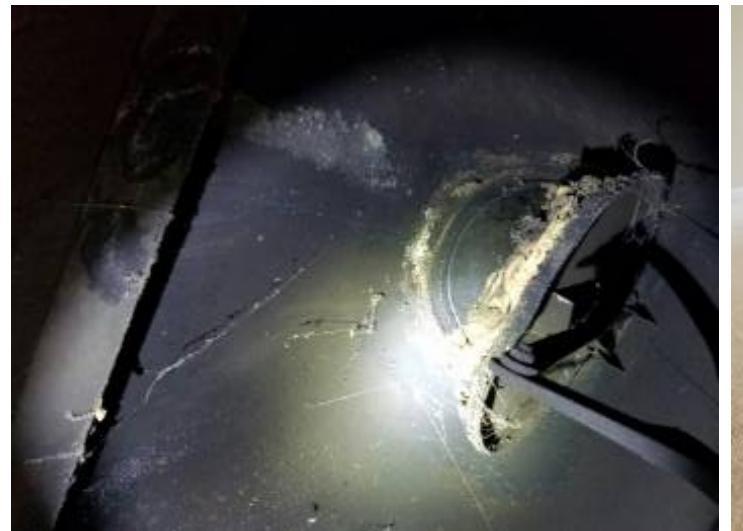
2.3. There is something attached to the top of the flue damper that resembles a bee nest but I did not leave open long enough to determine what it was. Estimated Cost \$100 - ??

some type of nest on top of damper

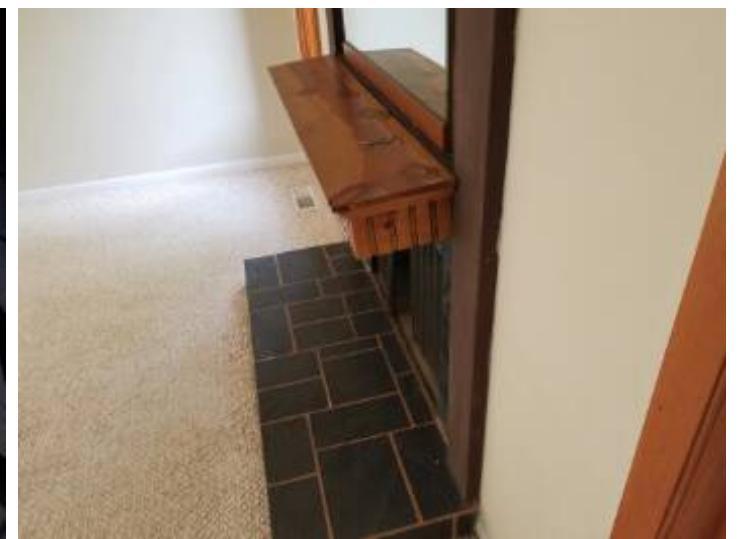
wood mantel too close / unsafe
