29 OBX Dr, Henrico, VA 23233 Inspection prepared for: Real Sample Real Estate Agent: No Agent -

Date of Inspection: 11/30/2016 Time: 9 - 12 PM Year Built: 38 yrs Size: 2330 sf Paid \$

Inspector: John Cranor VA Certified Home Inspector #3380000119 Exp.10/17 PO Box 1455, Glen Allen, VA 23060 Phone: 804-873-8534 Email: cranorinspectionservices@gmail.com House-Whisperer.com (M) TheHomeInspection.com

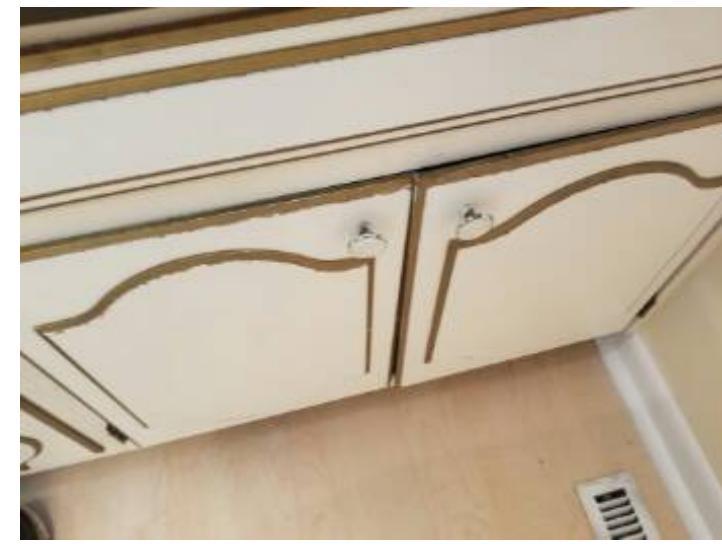
1.5. The vanity doors hit together when closed. Estimated Cost \$75

vanity doors worn / hit together

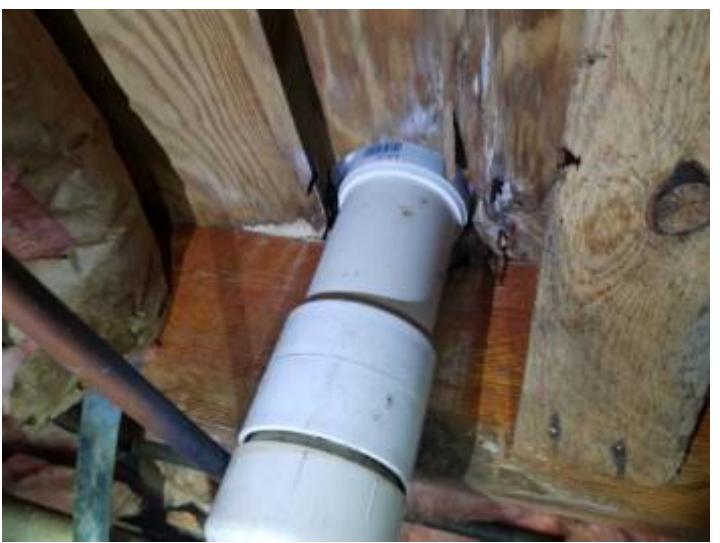
leaking around toilet viewed from crawl space

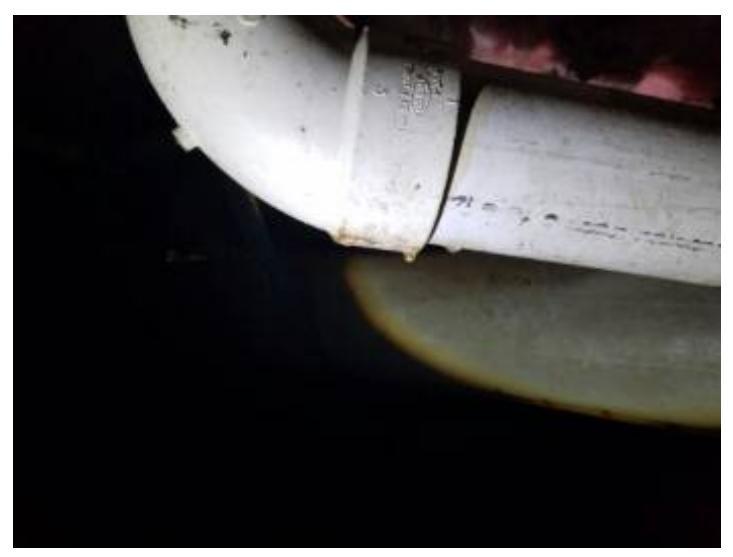
water dripping off drain under toilet

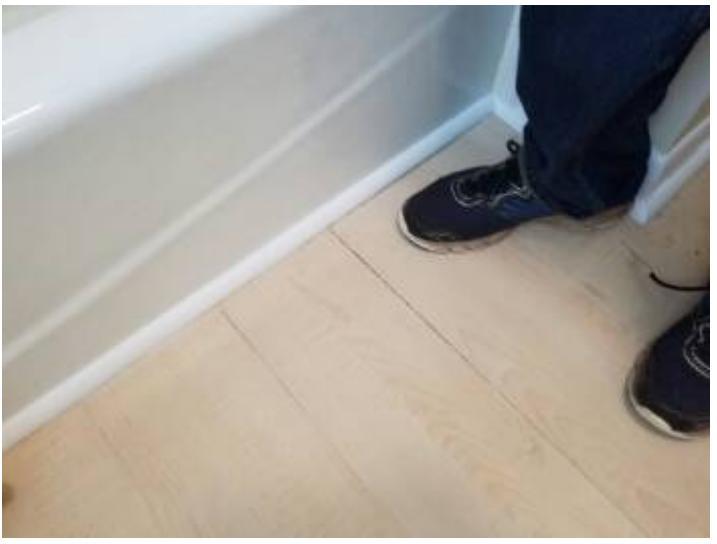
2.1. The floor near the tub is weak and feels like there is moisture related damage. Estimated Cost \$250 - 400

weak / damaged floor at tub

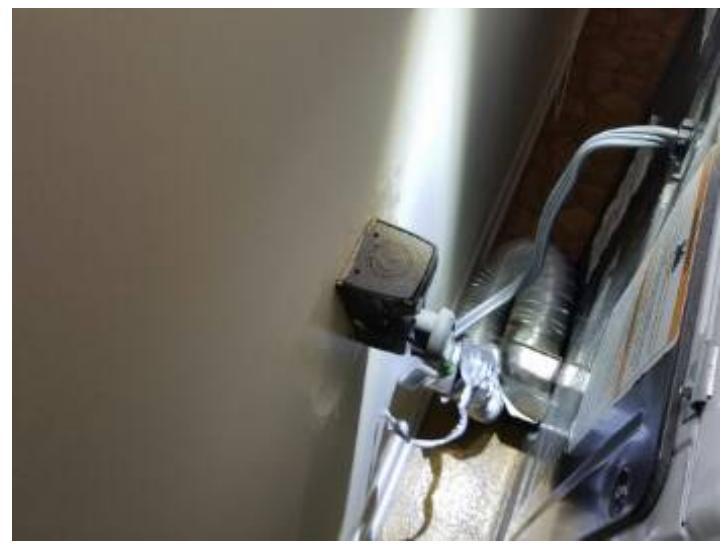
1.2. The dryer duct is damaged. Recommend replacing duct. Estimated Cost \$150

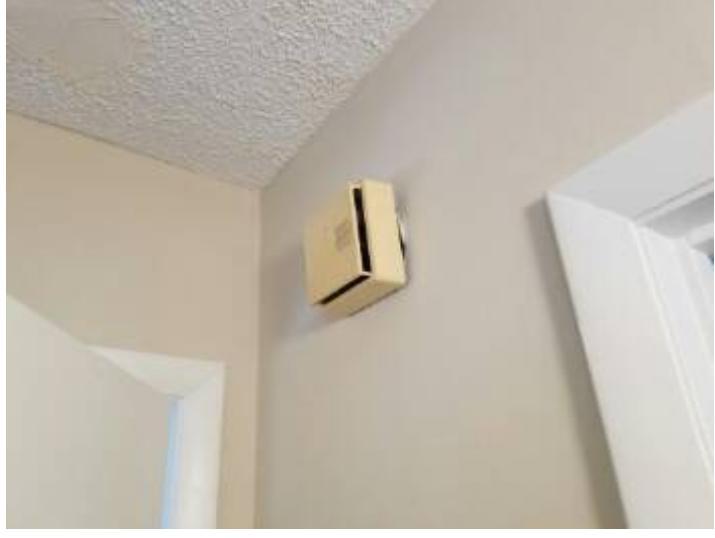
1.2. The smoke alarm is old and beyond its expected service life. Recommend replacing and adding additional alarms in each bedroom and on each level of the home

old

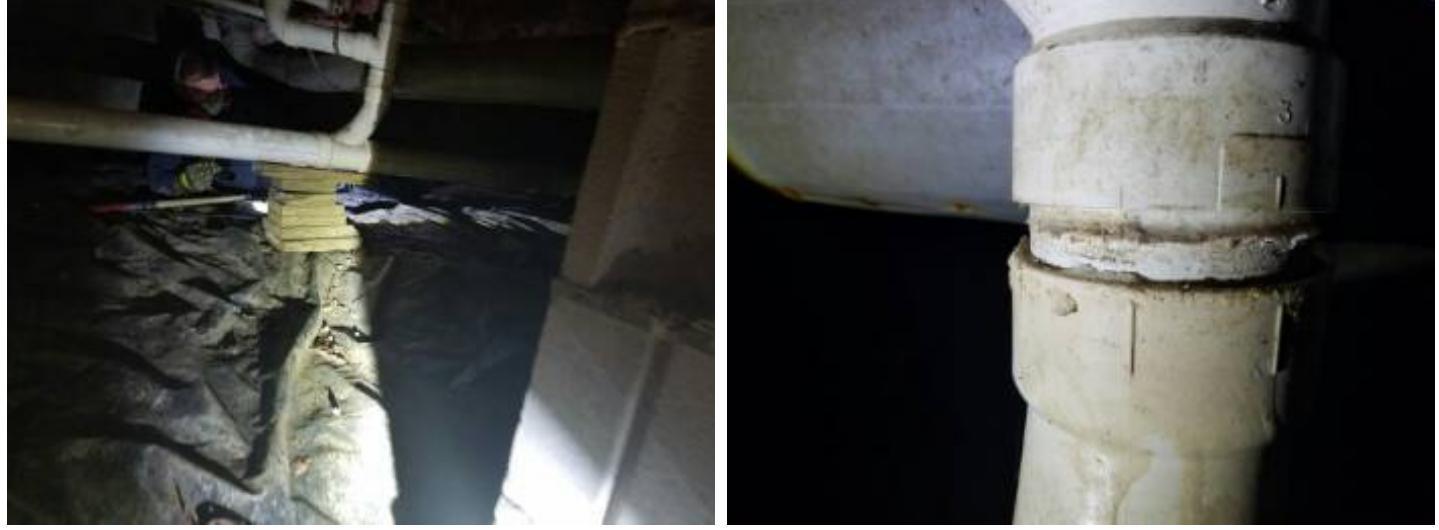
3.1. There is a section of the PVC drain pipe in crawl space that is supported with wood blocks which is substandard. The glued joint directly above the wood block support has failed and is leaking. Recommend having evaluated and corrected by a licensed plumbing contractor. Estimated Cost \$300 - 400

drain improperly supported with wood blocks+

glued joint has failed and its leaking

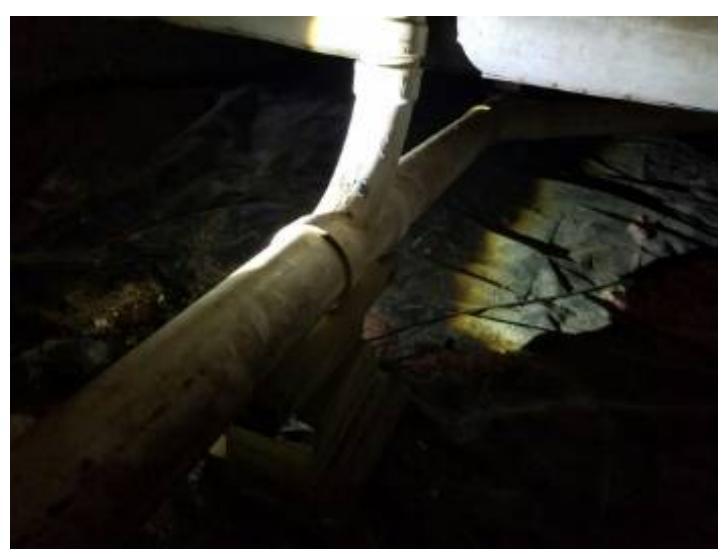
drain improperly supported with wood blocks

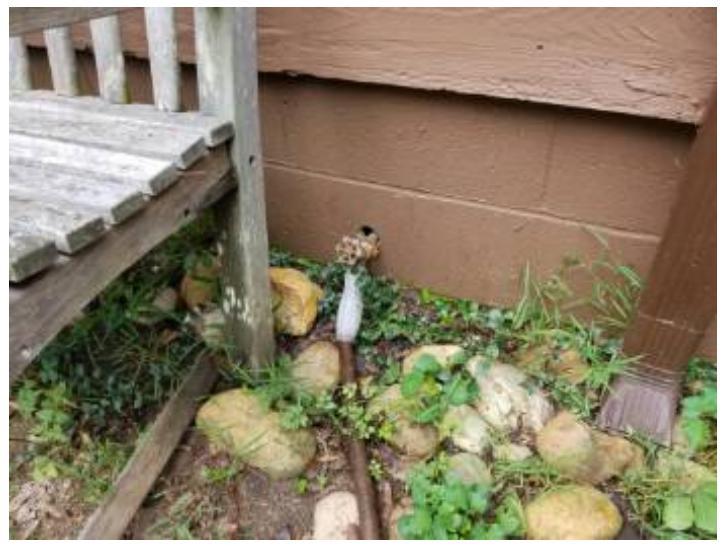
4.1. The hose bibb is loose and has a gap around it. Should be secured and sealed to prevent vermin entry. Estimated Cost \$75

gap around the house bibb

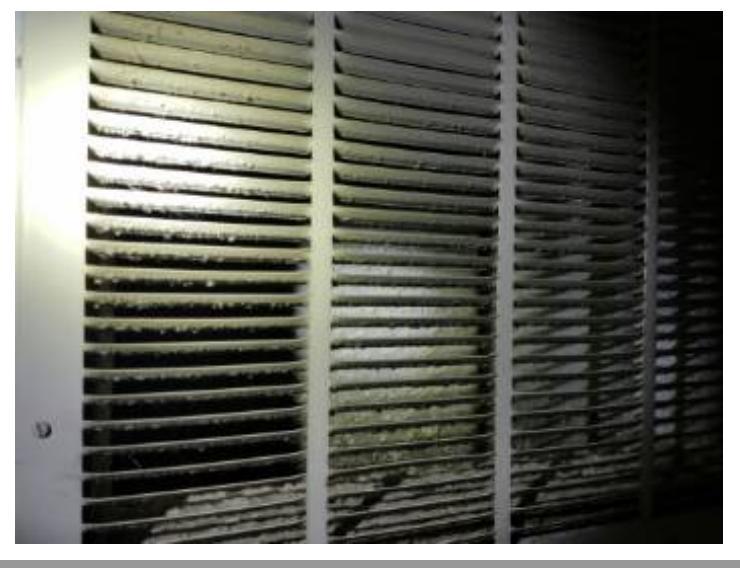
2.1. Low air flow coming from registers. The filter is not accessible without tearing and removing tape and it appears to be taped since it was originally installed. I suspect the filter is clogged and restricting air flow. The interior of the ducts (where visible) is unusually dirty. The duct system should be cleaned. Recommend having evaluated and corrected by a licensed mechanical contractor. Estimated Cost \$500 - 1250

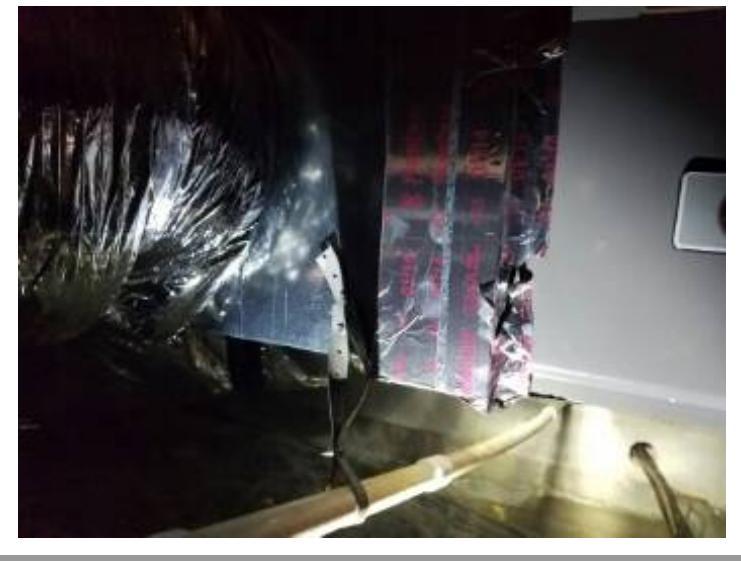
4.1. There is a filter located in or near the air handler located in crawl space. The filter is taped in and it appears to have been there since the system was originally installed 2 years ago. There is one small hole in the tape that is leaking air. I suspect the filter is clogged with dirt and may be why the air flow seems low. The filter should be readily accessible and easily exchangeable by the home owner for monthly replacing. Estimated Cost \$150 - 200

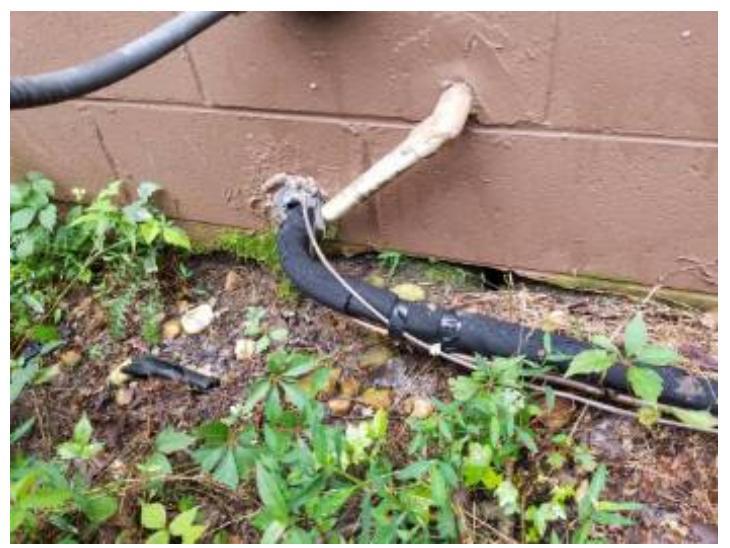
5.1. The A/C condensation drain pipe on exterior is turned an unusual angle and its not extended away from the house far enough. Should extend at least 3 feet away from the foundation. Estimated Cost \$75 - 100

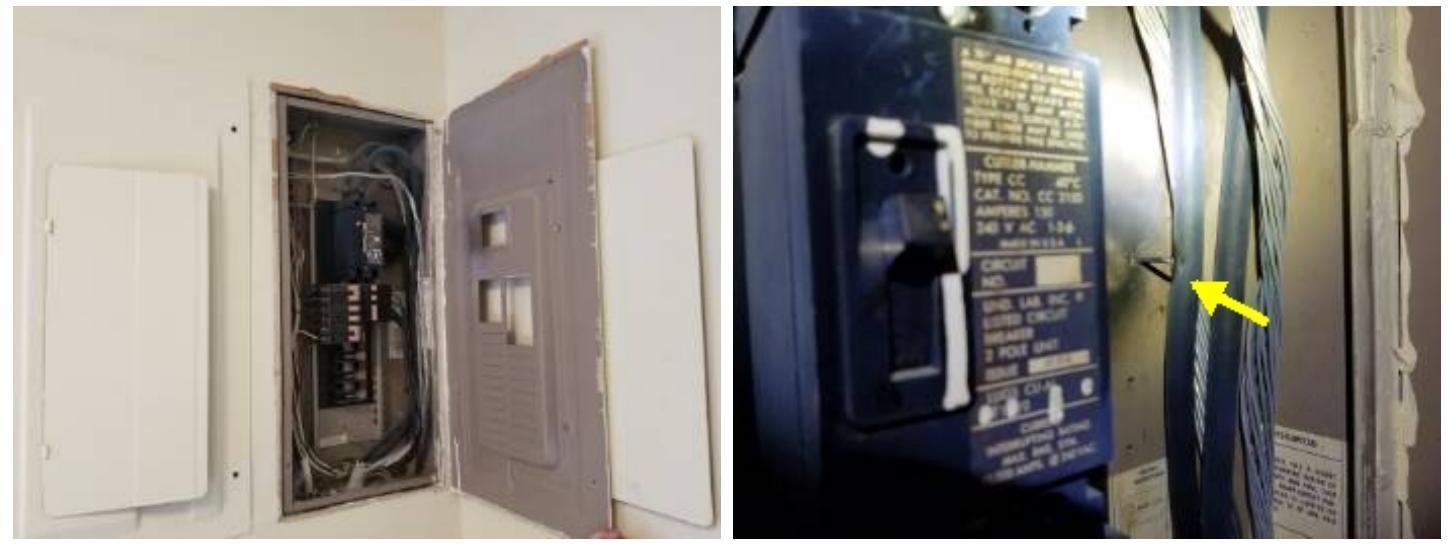
2.2. One breaker has two wires connected to it (double tapped) which is not permitted. Each circuit wire should be served by it own separate breaker. Estimated Cost \$100 - 125

nail penetrated electrical service cable

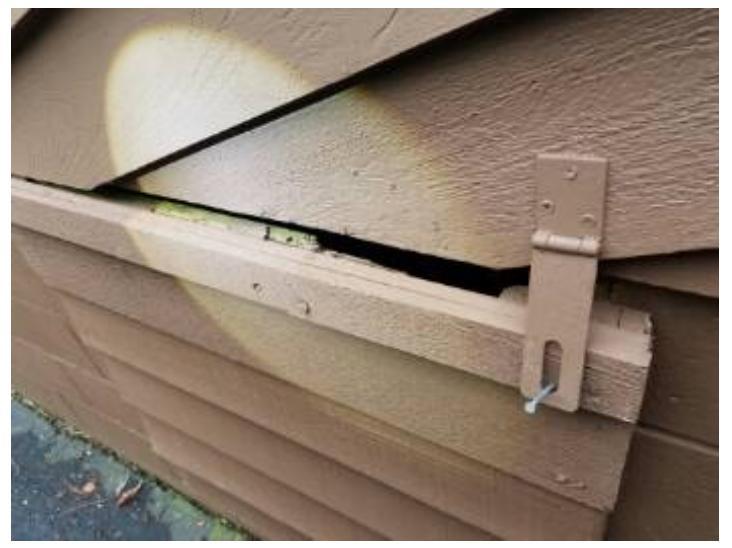
1.1. There is a large open gap at crawl space door. Estimated Cost \$75

large open gap at crawl space door

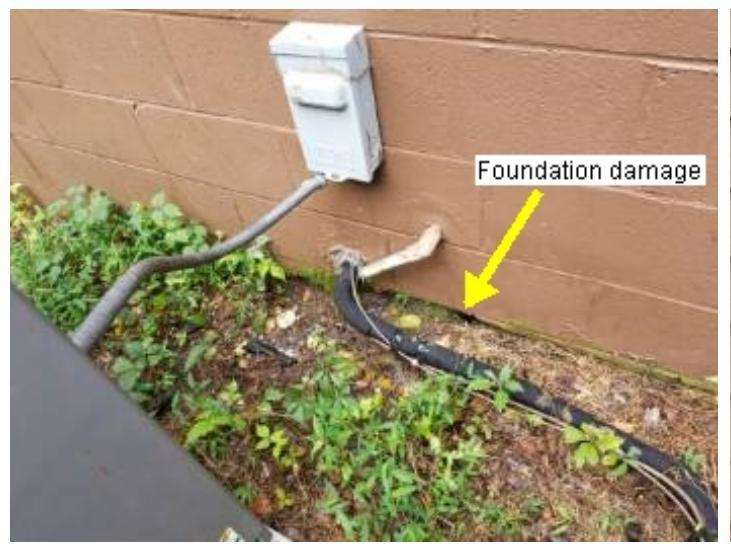
foundation damage

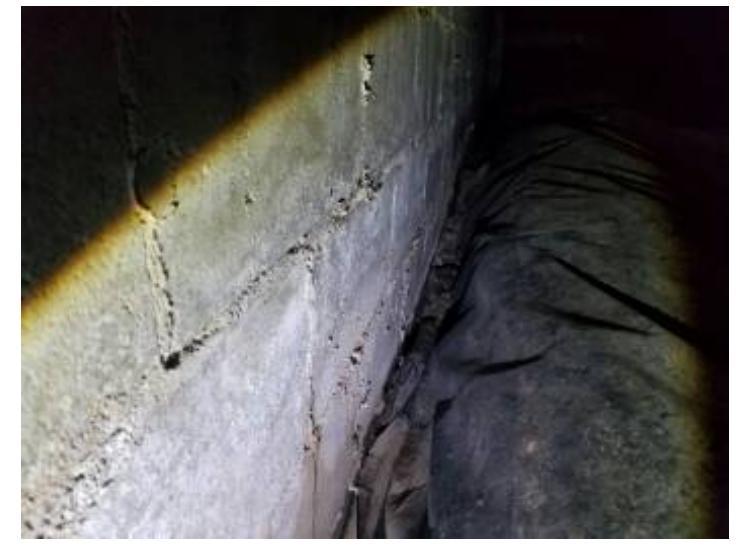
foundation was never back filled

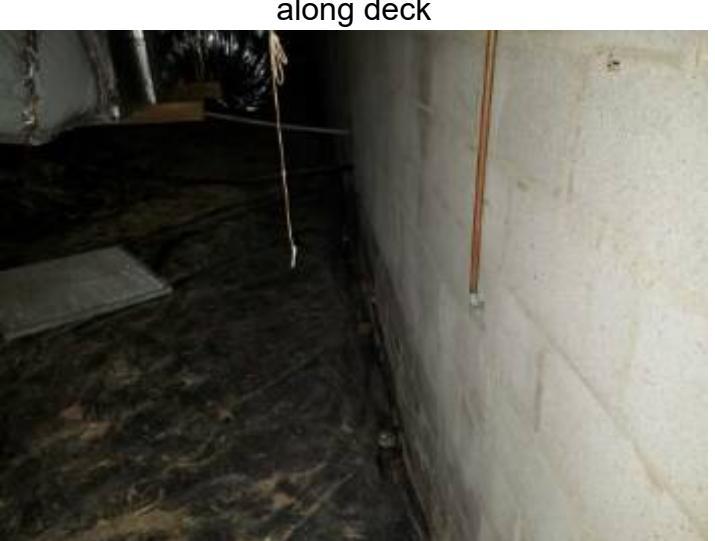
foundation was never back filled

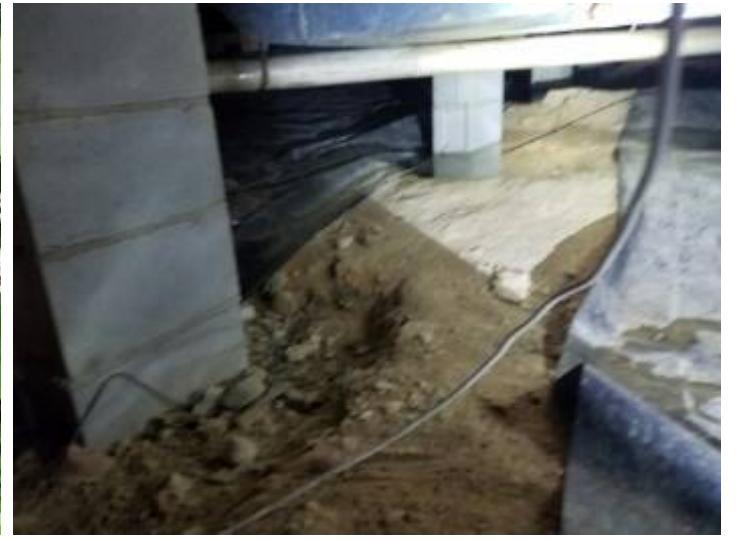
4.2. The polyethylene vapor barrier in the crawl space is not complete and/or its bunched up leaving too much of the soil exposed. All exposed soil should be covered to help control moisture. Estimated Cost \$250 - 350

exhaust duct from kitchen coming through a foundation vent

incomplete vapor barrier on ground

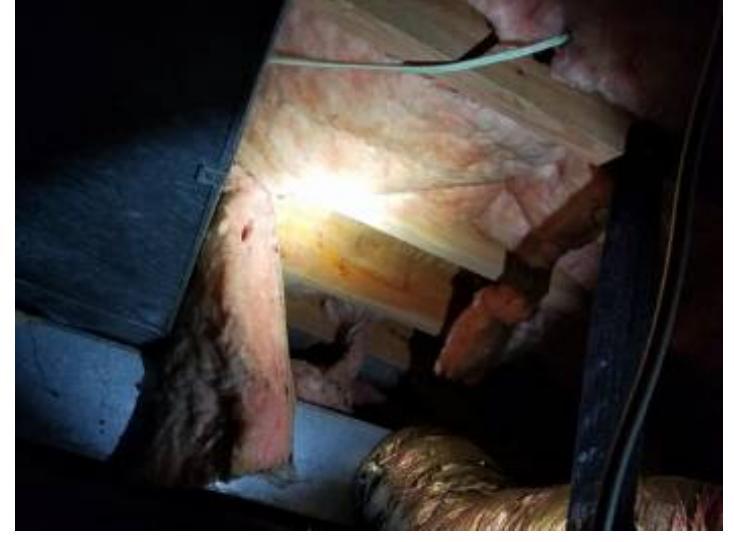
6.1. Many pieces of insulation have fallen down out of position. Recommend replacing and reinstalling as necessary. Estimated Cost \$350 - 450

,missing / falling insulation
