29 OBX Dr, Henrico, VA 23233 Inspection prepared for: Real Sample Real Estate Agent: No Agent -

Date of Inspection: 11/30/2016 Time: 9 - 12 PM Year Built: 38 yrs Size: 2330 sf Paid \$

Inspector: John Cranor VA Certified Home Inspector #3380000119 Exp.10/17 PO Box 1455, Glen Allen, VA 23060 Phone: 804-873-8534 Email: cranorinspectionservices@gmail.com House-Whisperer.com (M) TheHomeInspection.com

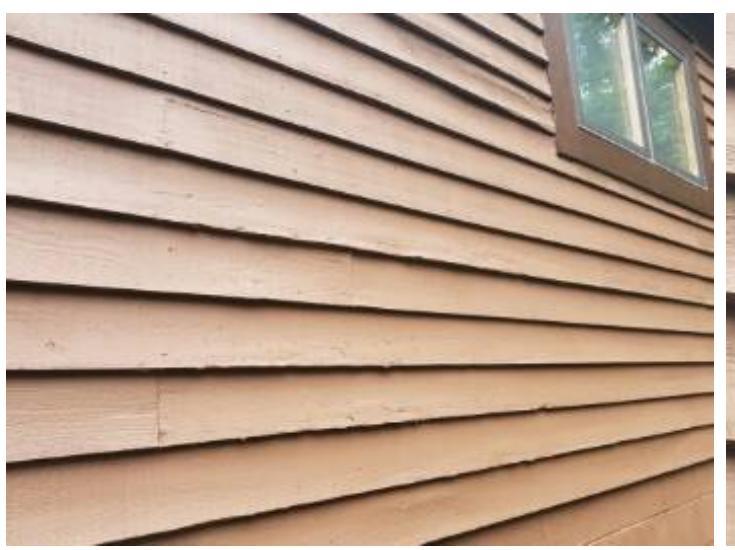
patching

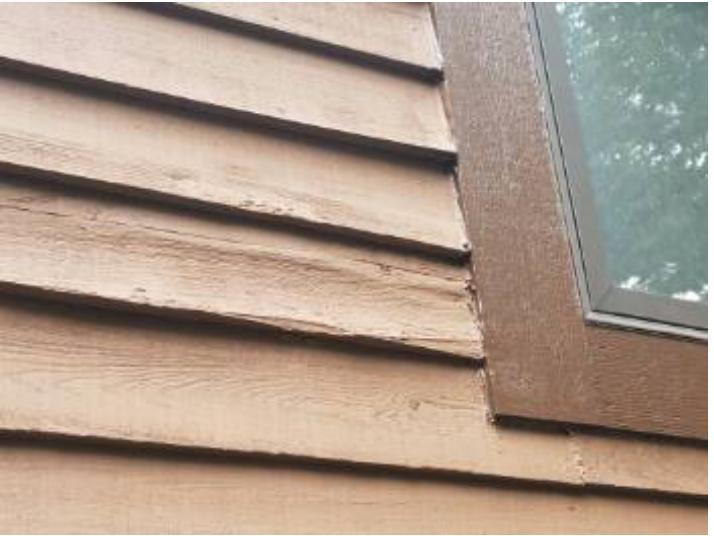
patching

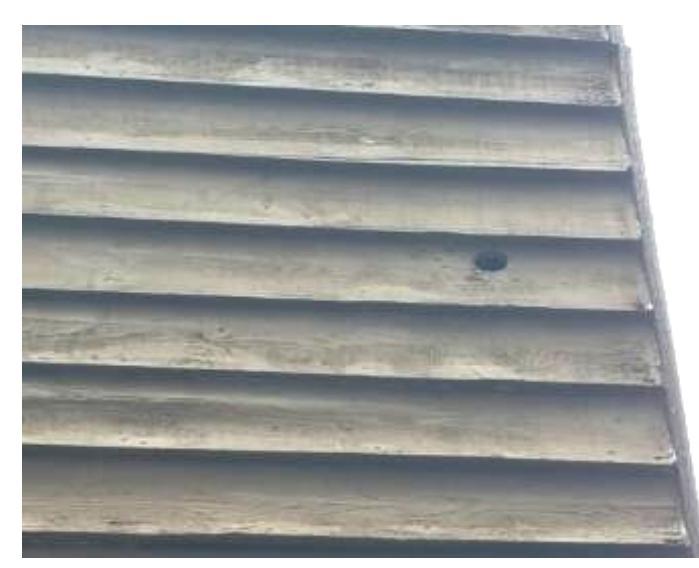
hole on rear

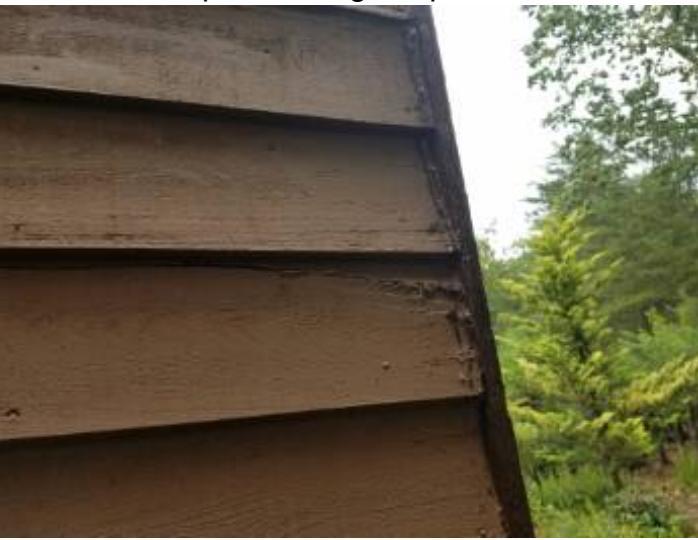
patched

damaged siding

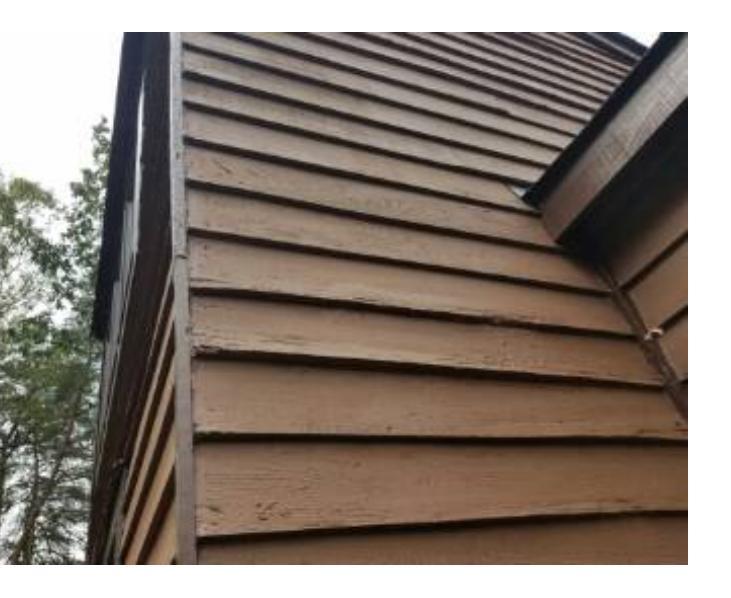
split siding

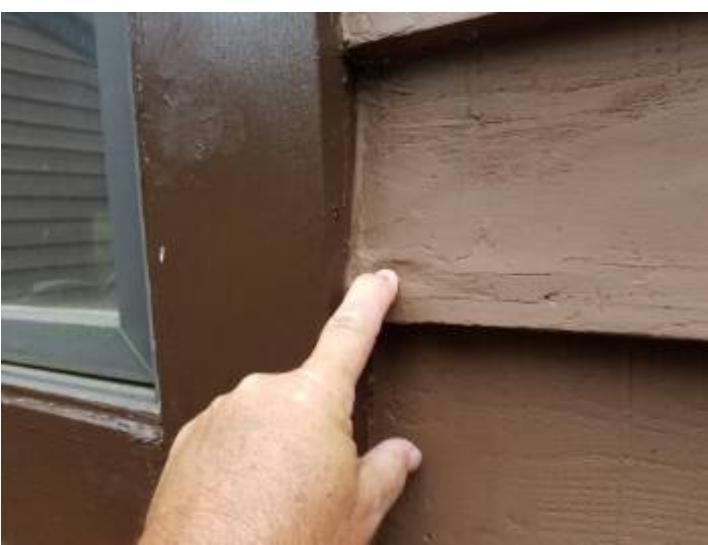
splits

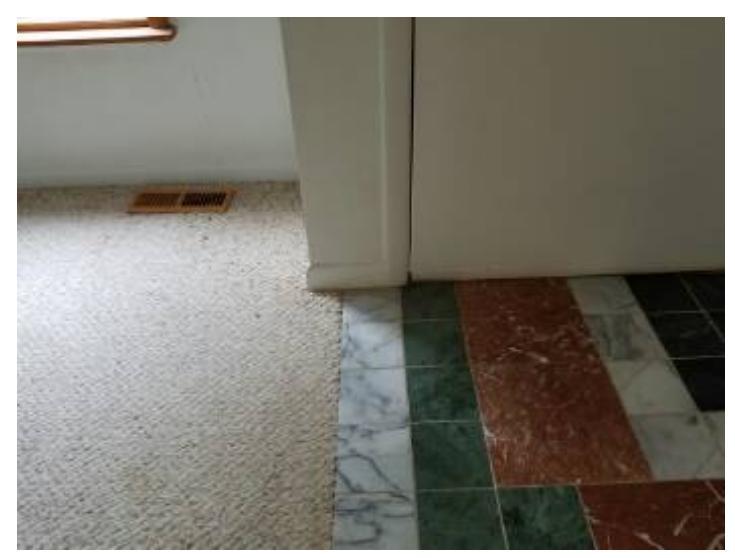
daylight around door

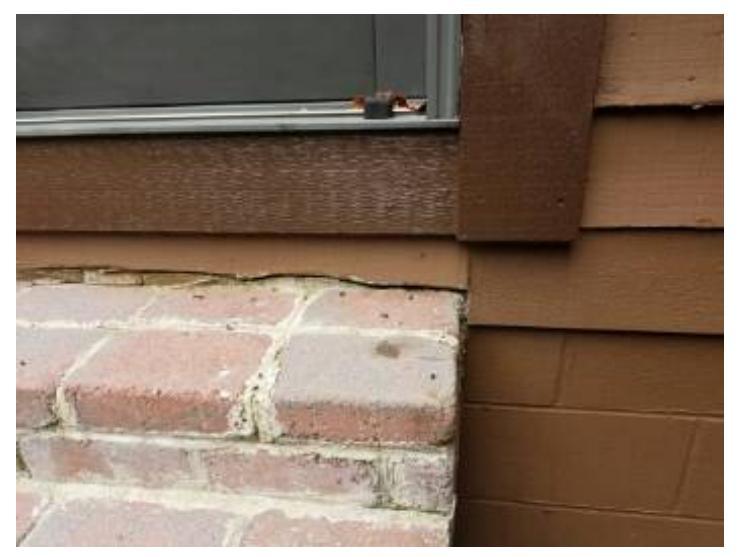
open gaps around doors

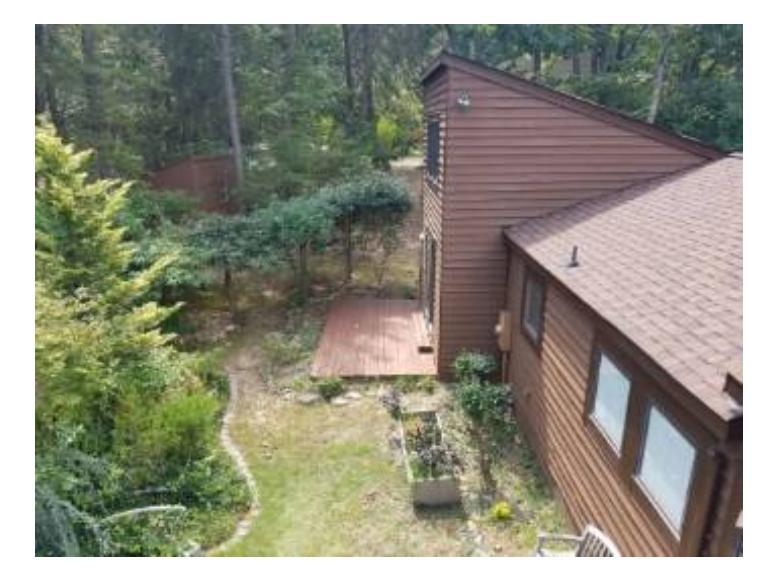
deck is weathered

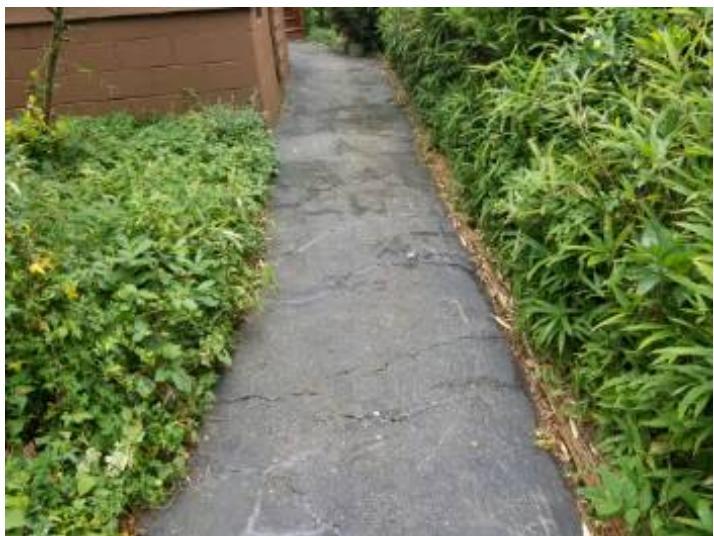
9.1. The asphalt walkway is cracked and deteriorated which is typical of an old asphalt. Usable but in poor condition

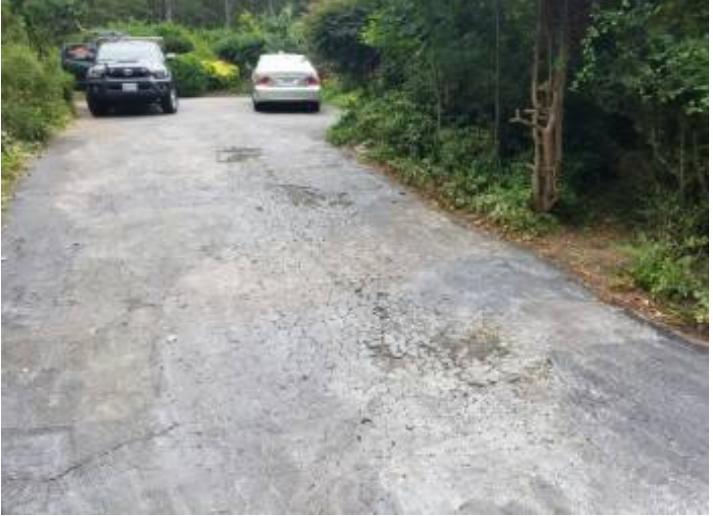
poor condition

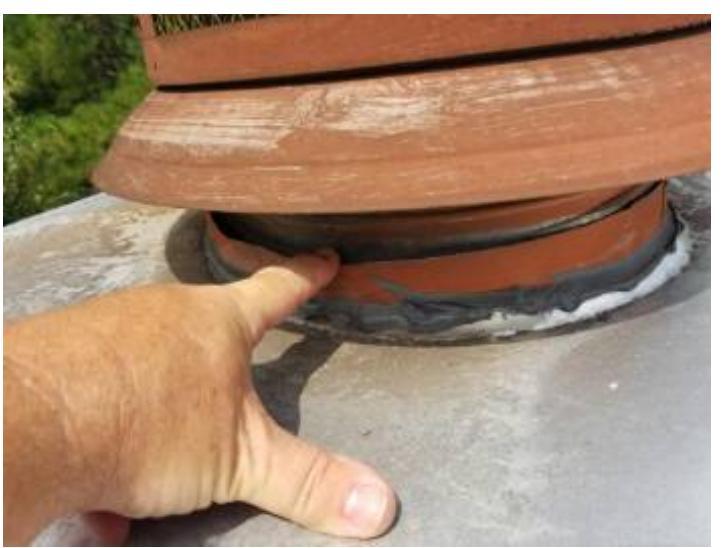
5.2. Both of the fireplace chimney flue's have open gaps at the storm collar as shown in photo. This area should be water tight to prevent water from leaking down around the flue. Estimated Cost \$150 - 300
Page 25 Item: 6	Roof Drainage System	6.2. The gutters have been removed but one of the down spouts was left in place. Gutters are not a requirement but are strongly recommended to help control water. Recommend re installing gutters. Estimated Cost \$2500 - ??
Kitchen	I	
Page 27 Item: 1	Kitchen Sink	1.1. Plumbing fixture is leaking around handle. Estimated Cost \$150 - 350
Page 28 Item: 4	Kitchen Appliances	4.1. The refrigerator has cracks and damage on inside and the door is dented.
Page 29 Item: 5	Kitchen Walls, Ceiling & Floor	5.2. Loose floor transition strip in kitchen. Estimated Cost \$75
Interior

storm collar not water tight

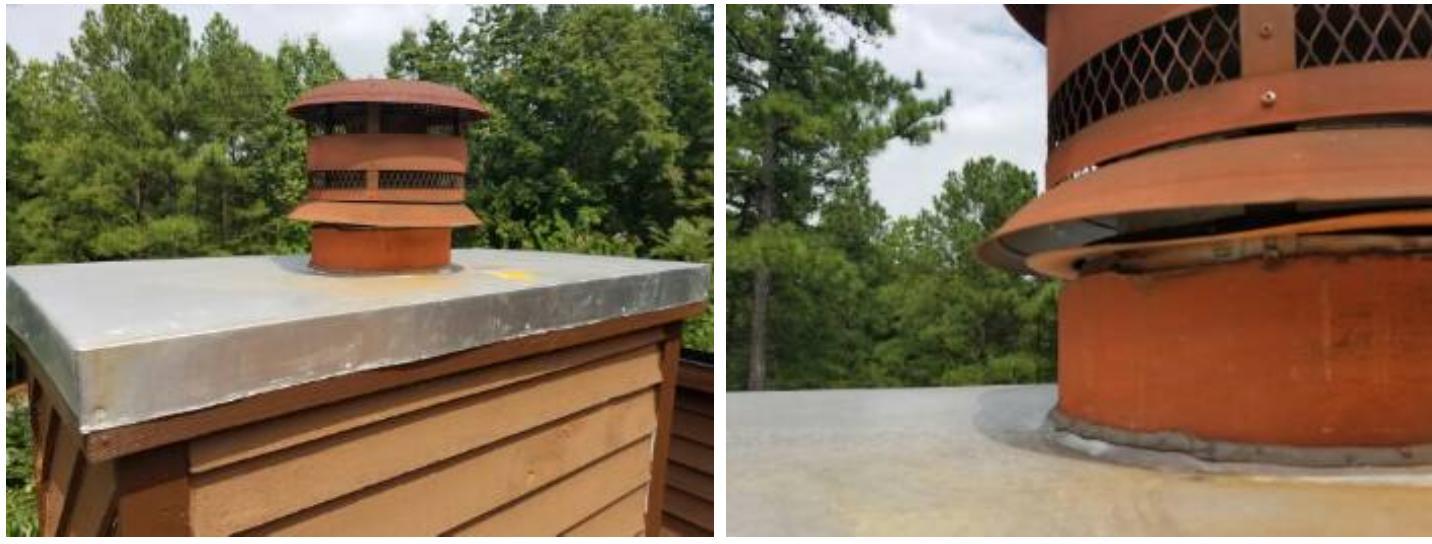
storm collar not water tight

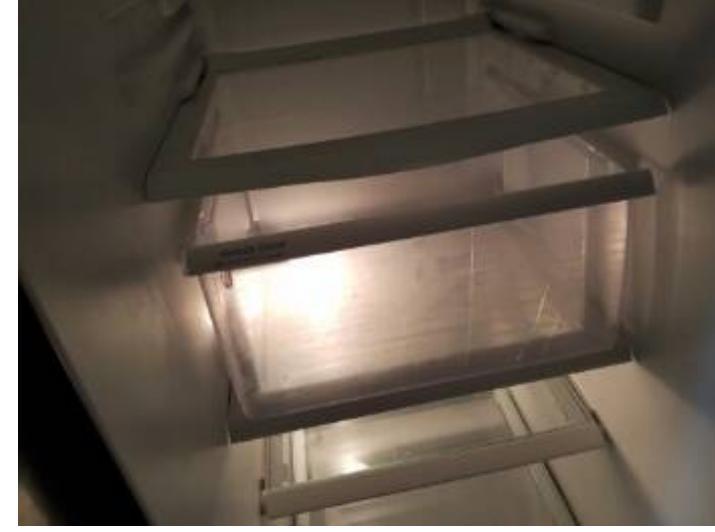
4.1. The refrigerator has cracks and damage on inside and the door is dented.

damaged refrigerator

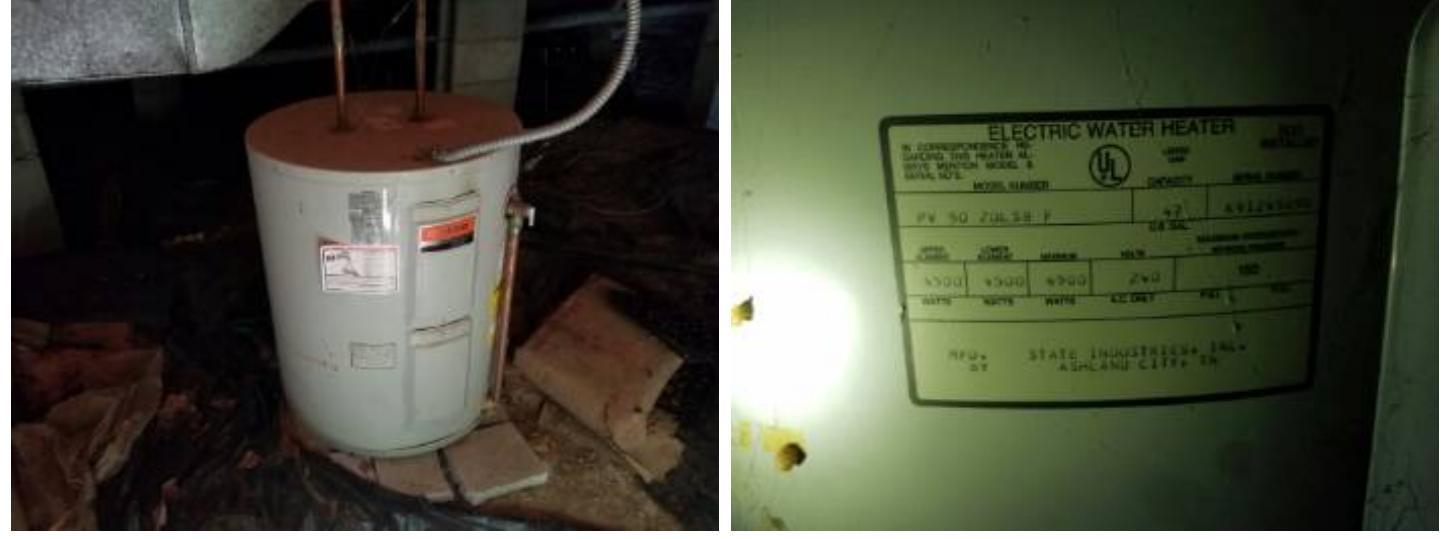
Description: Electric Water Heater • 25 years old (beyond its expected service life) • 47 gallons

1991 model

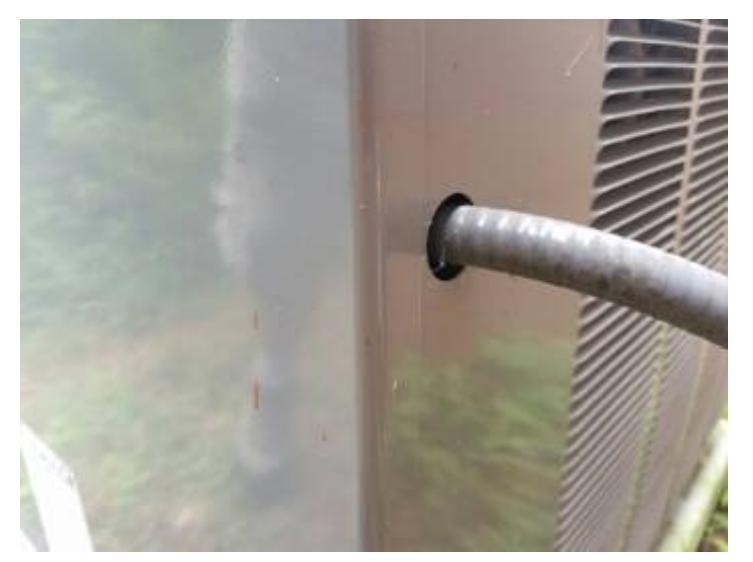
1.1. The electrical conduit not clamped at the outside condensing unit. Estimated Cost \$100 - 125

electrical conduit not clamped

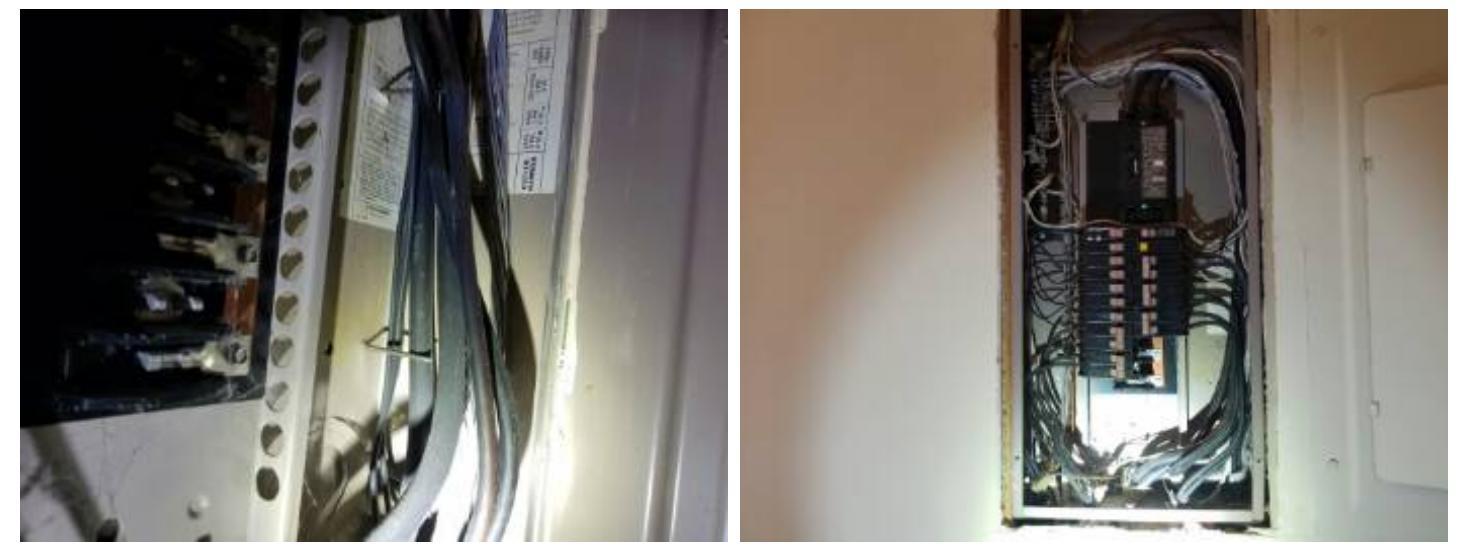
several nails penetrate the panel

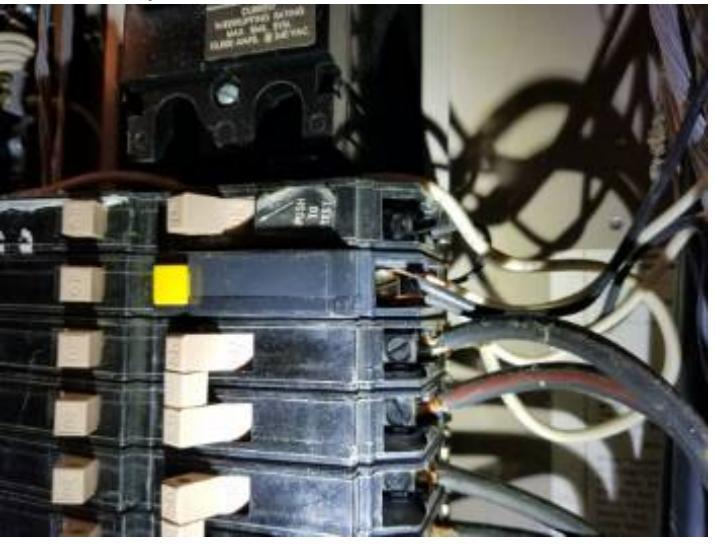
2.2. One breaker has two wires connected to it (double tapped) which is not permitted. Each circuit wire should be served by it own separate breaker. Estimated Cost \$100 - 125
Page 51 Item: 3	Receptacles, Switches & Light Fixtures	3.2. Receptacles loose in wall in the following: loft area, living room. Estimated Cost \$100 - 150

double tap

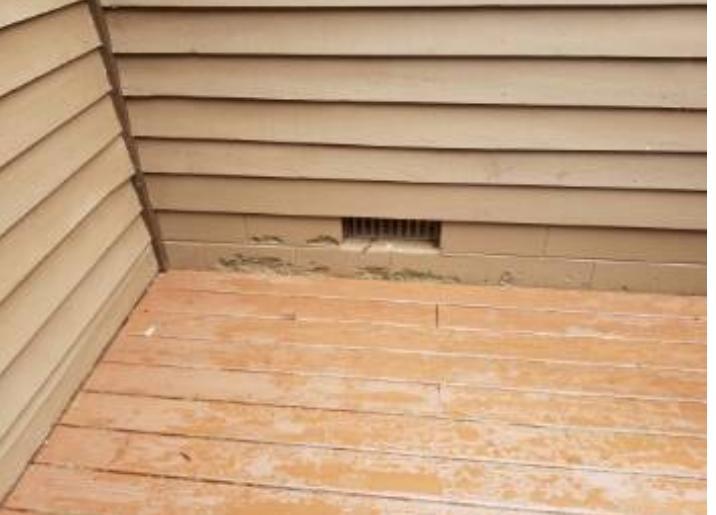
Page 53 Item: 2	Crawl Space Foundation	2.1. There is moisture related surface damage on the concrete block foundation at the grade and along the deck. Recommend repairs to the concrete blocks and improving grade and drainage around the house to help prevent frost damage. The foundation was never back filled after construction as required. Recommend having foundation evaluated by licensed qualified engineer and/or licensed qualified foundation repair contractor and have corrected as necessary. Estimated Cost \$1000 - ??
Page 55 Item: 4	Crawl Space Ventilation / Moisture Control	 4.1. The kitchen exhaust duct is improperly running through a foundation vent which makes the vent inoperative. Recommend correcting by properly terminating the exhaust duct and replacing the foundation vent. Estimated Cost \$250 - 350 4.2. The polyethylene vapor barrier in the crawl space is not
		complete and/or its bunched up leaving too much of the soil exposed. All exposed soil should be covered to help control moisture. Estimated Cost \$250 - 350

surface damage on cement block foundation along deck

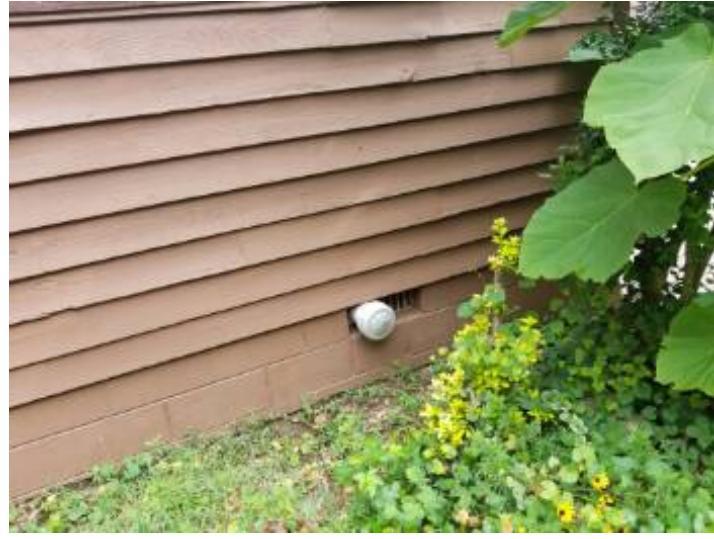
4.1. The kitchen exhaust duct is improperly running through a foundation vent which makes the vent inoperative. Recommend correcting by properly terminating the exhaust duct and replacing the foundation vent. Estimated Cost \$250 - 350

exhaust duct from kitchen coming through a foundation vent

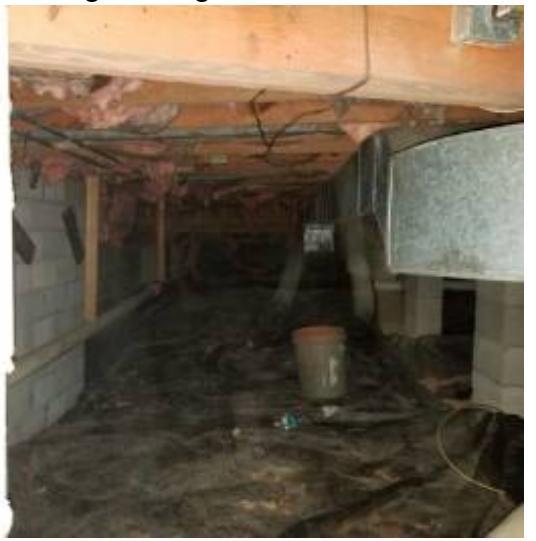
Page 55 Item: 6	Crawl Space Insulation	6.1. Many pieces of insulation have fallen down out of position. Recommend replacing and re-installing as necessary. Estimated Cost \$350 - 450

insulation falling down everywhere

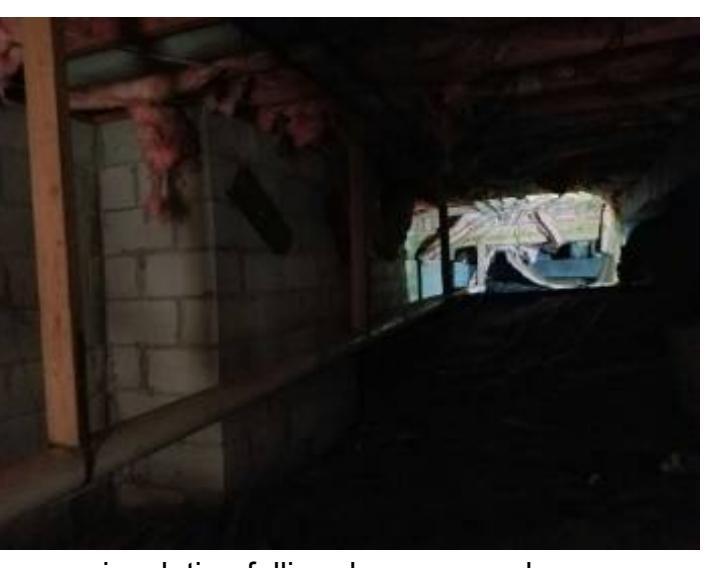
insulation falling down everywhere
